# **THE NATION MUNICIPALITY**

## **VILLAGE OF LIMOGES LIMOGES SEWAGE LAGOONS**

### **REPORT ON REPAIR WORKS TO LEAKS**

**JANUARY 2003**

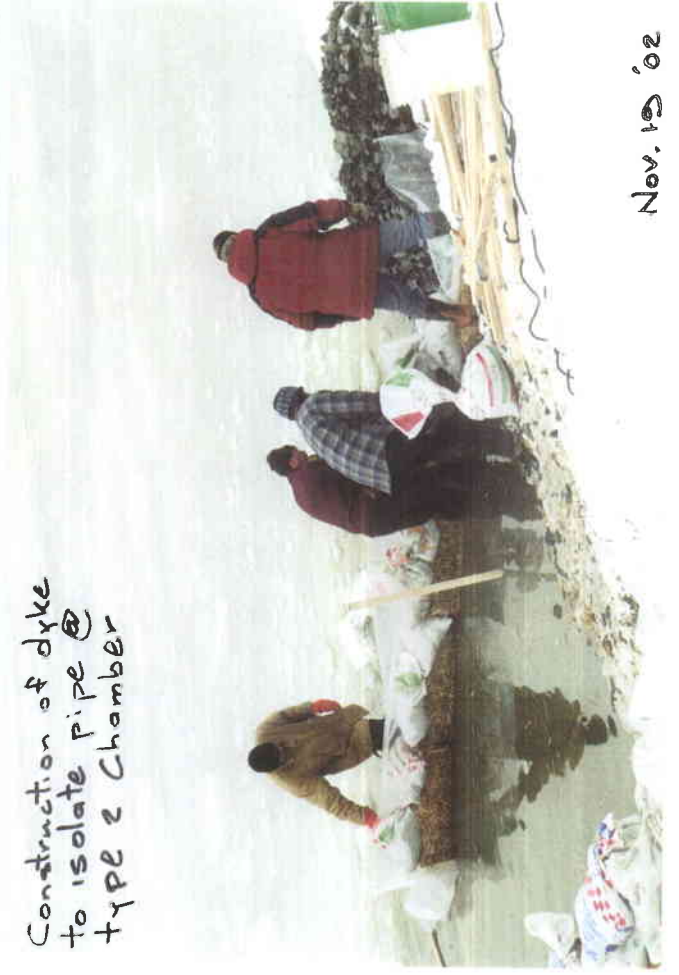
Construction of dyke  
to isolate pipe @  
type 2 chamber

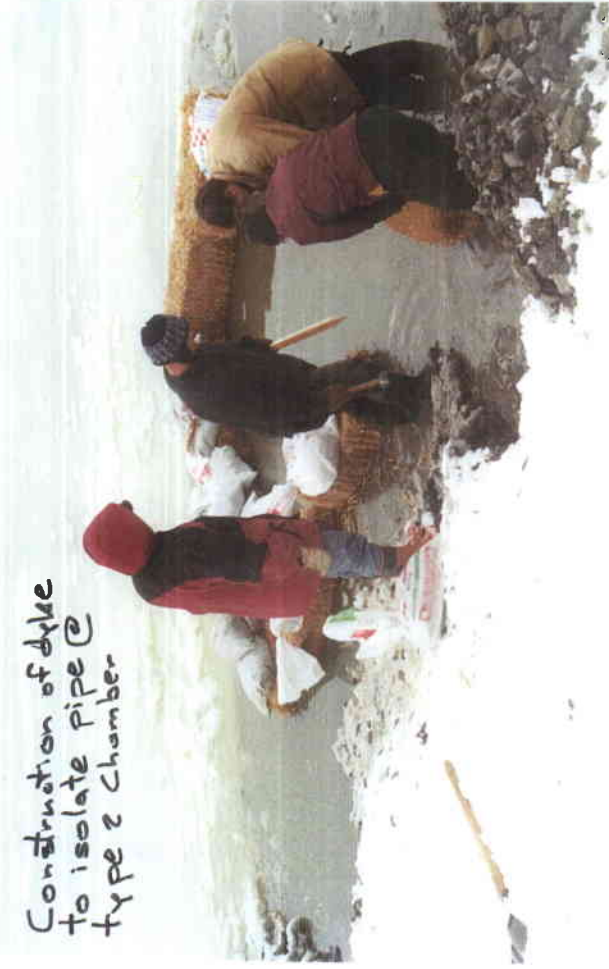
Nov. 19 '02

dyke @ type 2 chamber

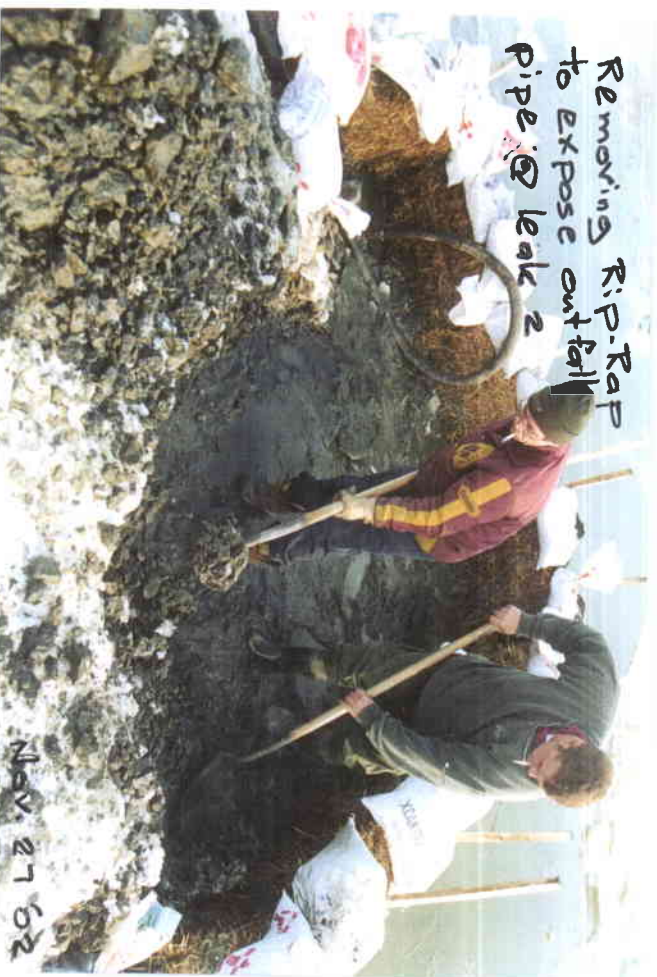
Nov. 27 '02

Removing R.P.-RAP  
to expose outfall  
pipe @ leak 2

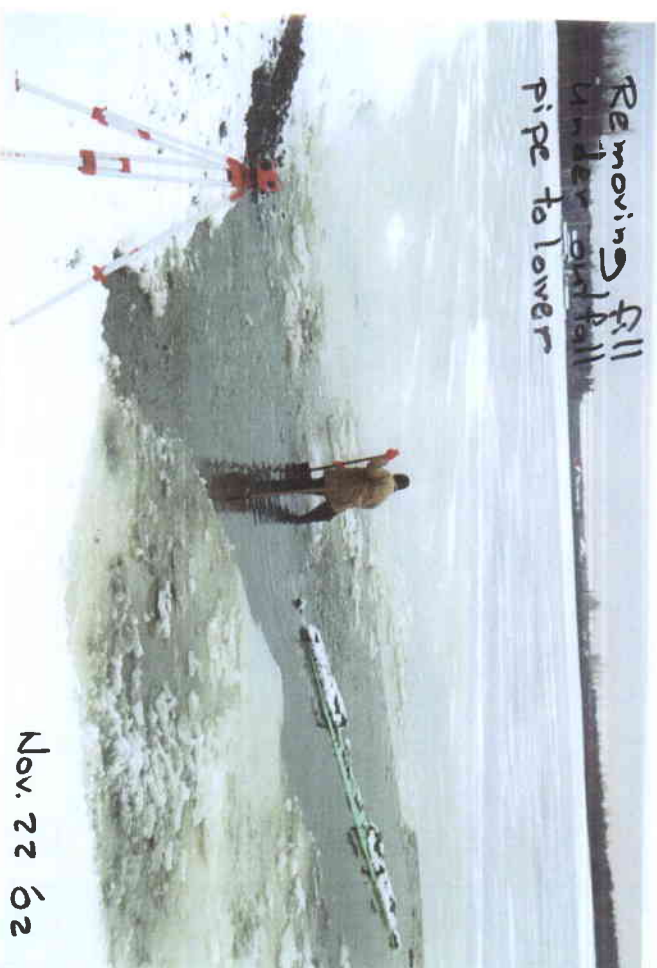
Nov. 22 '02

As shown on the attached photographs had a portion of the pipe lifted from its original position due to the formation of ice inside the pipe.

Removing fill  
under outfall  
pipe to lower

The grade of the pipe was properly restored by removing the soil underneath and then by placing two (2) concrete ballasts of 3m<sup>3</sup>, 25mPa with a pumper truck over the existing pipe.

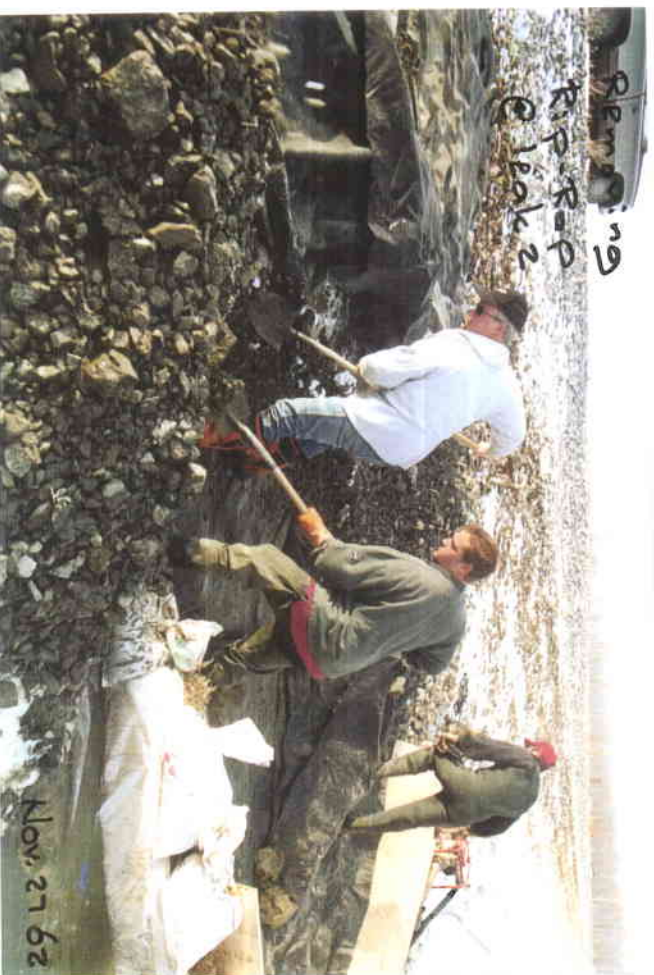
Nov. 27 '02

Removing  
R.P.-RAP  
@ leak 2

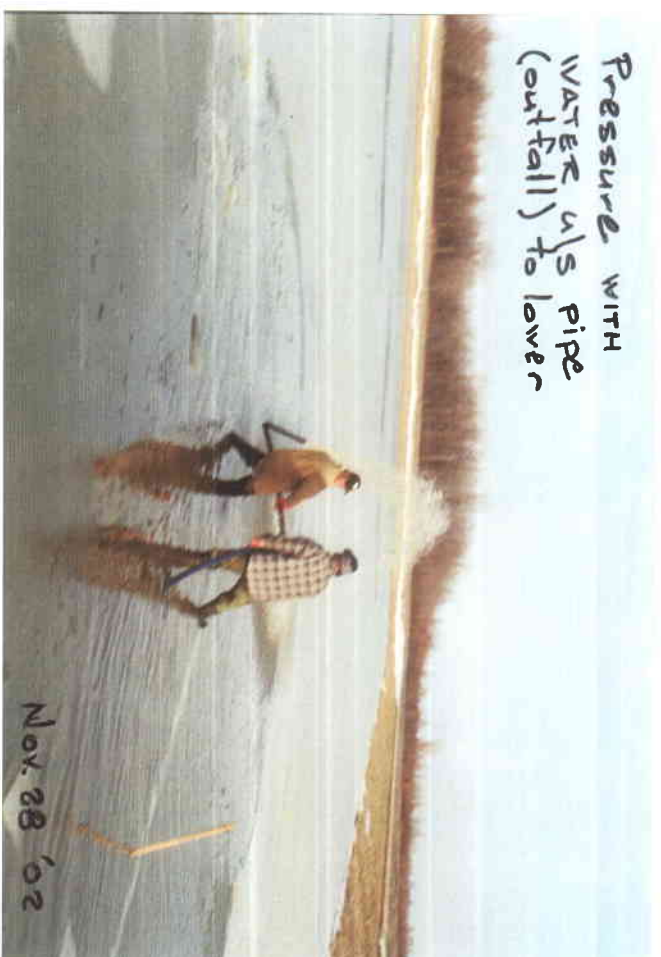
Nov. 28 '02

Pressure with  
water w/s pipe  
(outfall) to lower

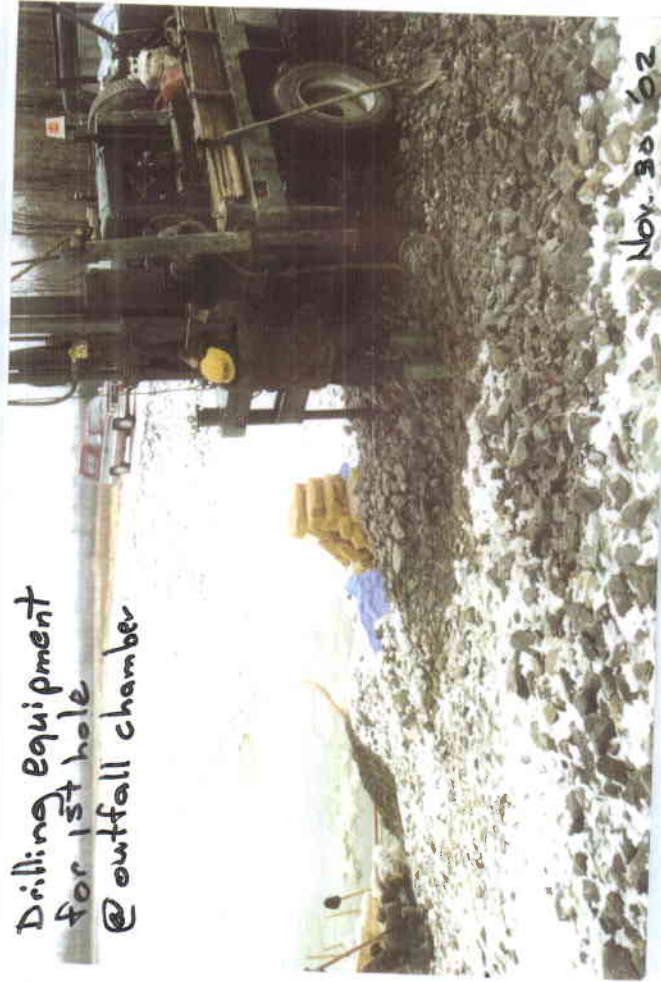
1st drill hole for bentonite  
@ outfall pipe

Marathon Drilling mobilized on site and spent the day filling 4 drill holes with bentonite grout. There were two (2) drill holes for each location. These injection points are shown on the revised contract drawings. Seven (7) bags of bentonite grout were used for the drill holes and twenty (20) bags of hole plug were used in the areas where the outfall and interconnecting pipes reach the berm or the HDPE liner at the inside toe of the berm. This material (hole plug) expands to 4 times its size and should add an extra protection to secure the leaks.

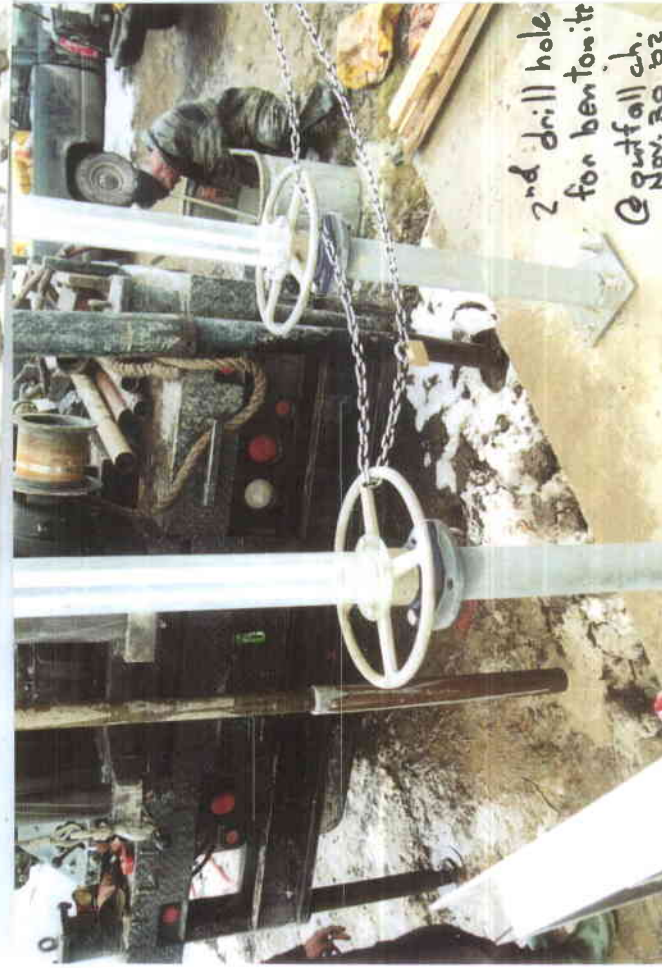
2nd drill hole  
for bentonite  
@ outfall ch.  
Nov. 30 '02

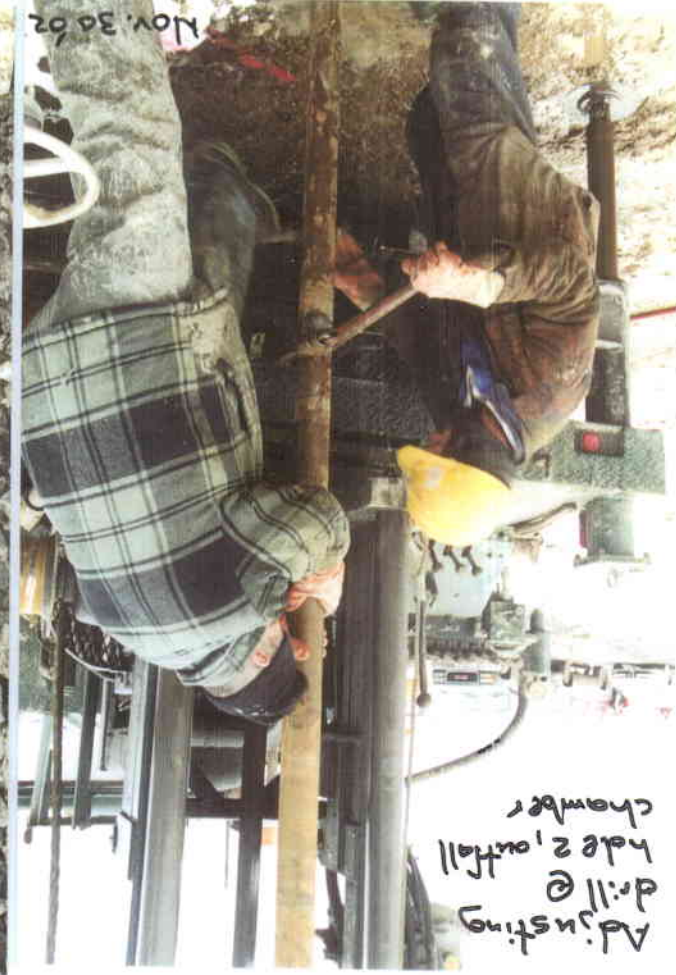
Adjusting  
drill @  
hole 2, outfall  
chamber

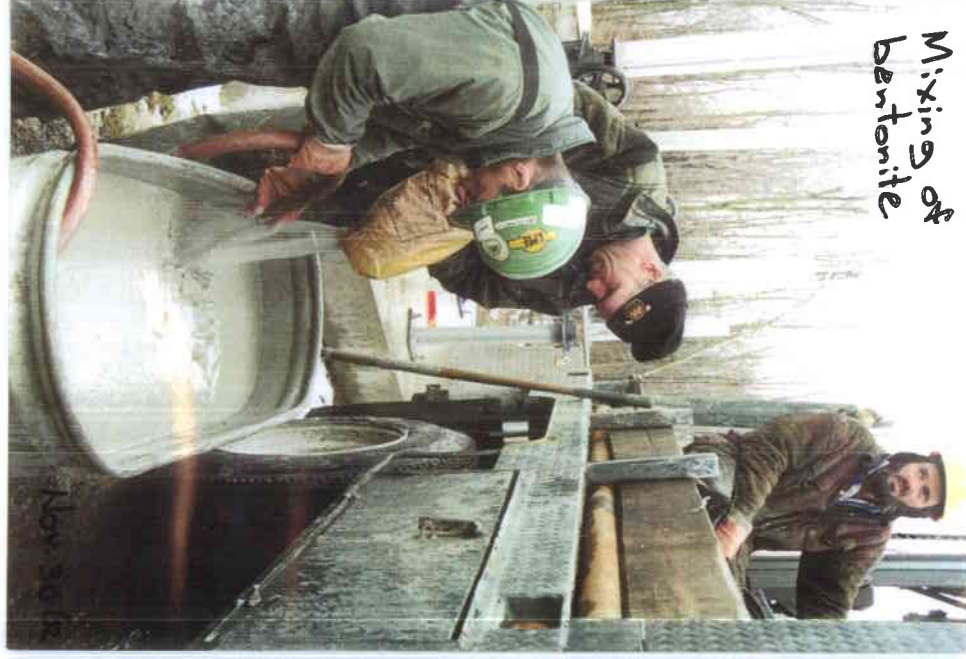
Mixing of bentonite

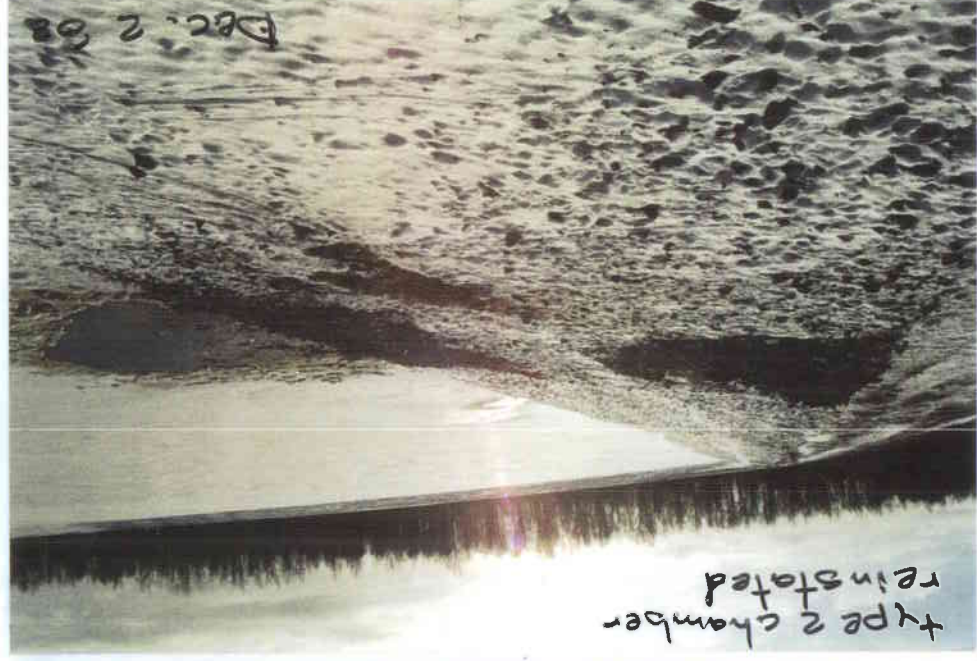
type 2 chamber reinstalled

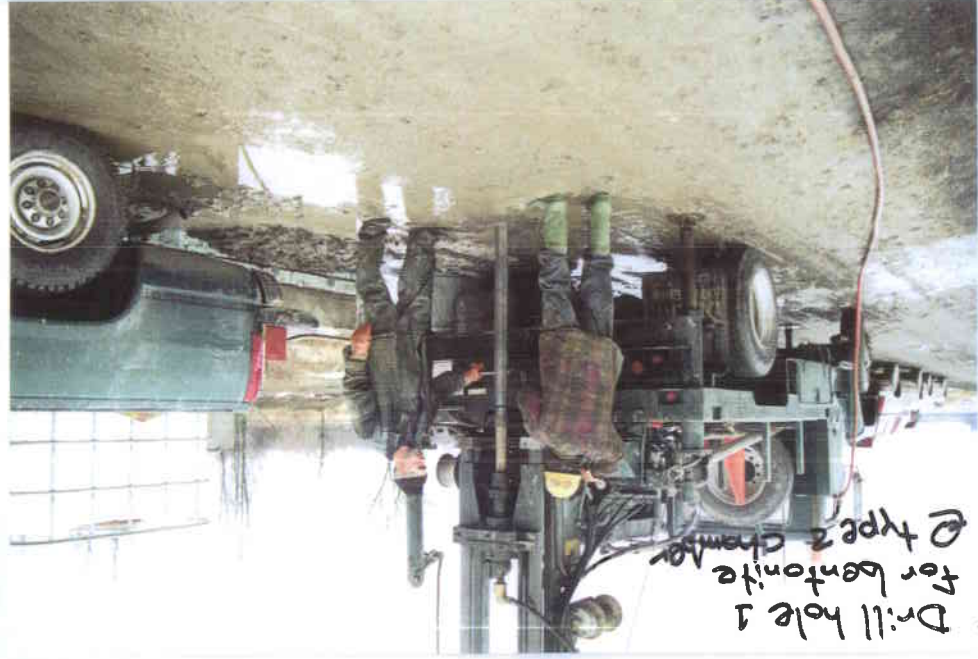
Drill hole 1 for bentonite @ type 2 chamber

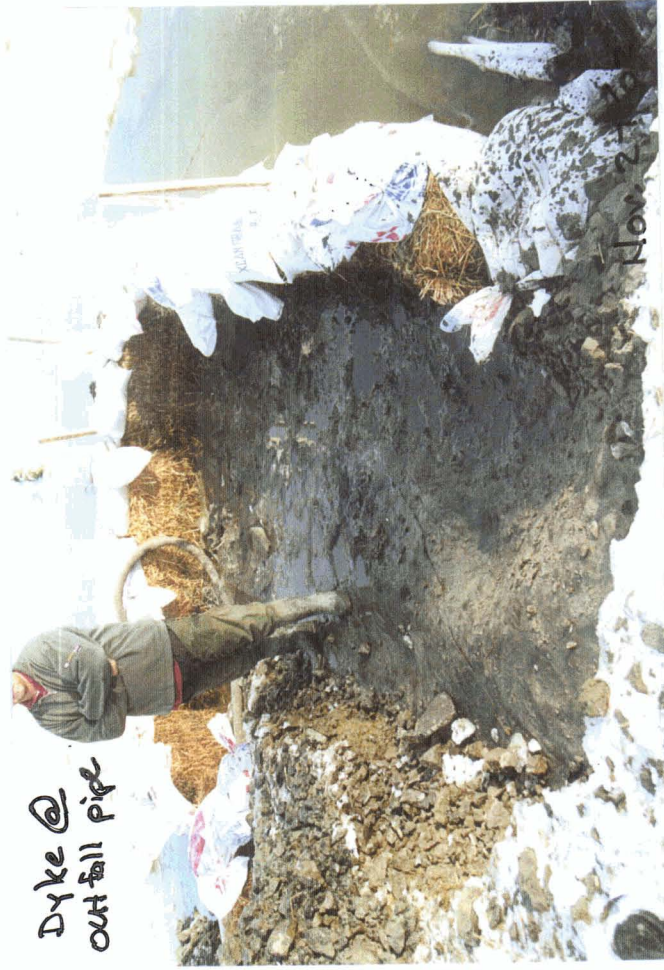
Nov 21 02

Dyke @  
outfall pipe

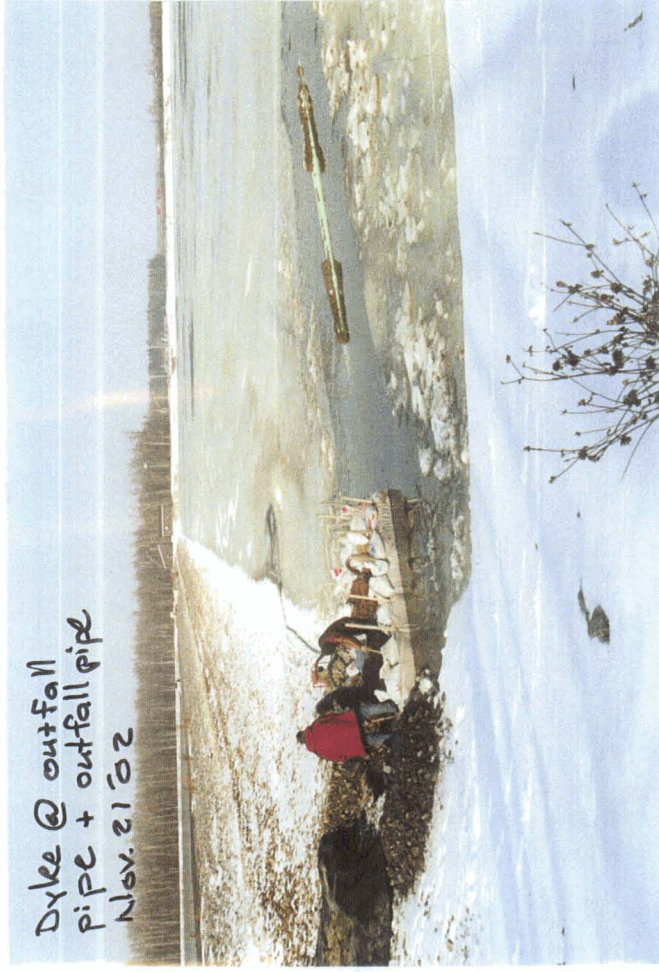
Dyke @ outfall  
pipe + outfall pipe  
Nov. 21 02

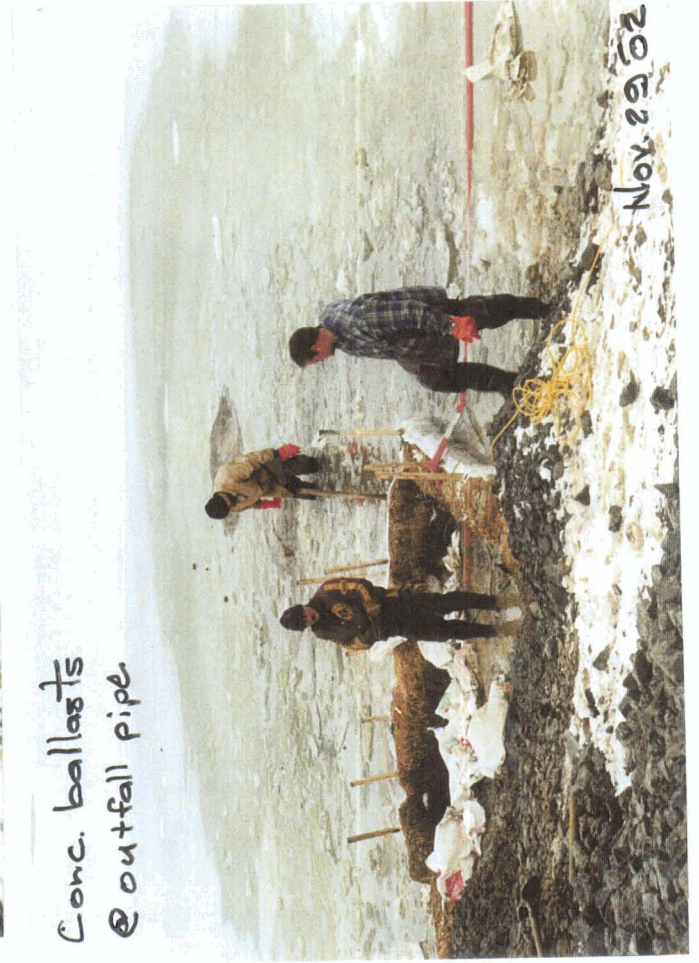
Nov 22 02

Conc. ballasts  
@ outfall pipe

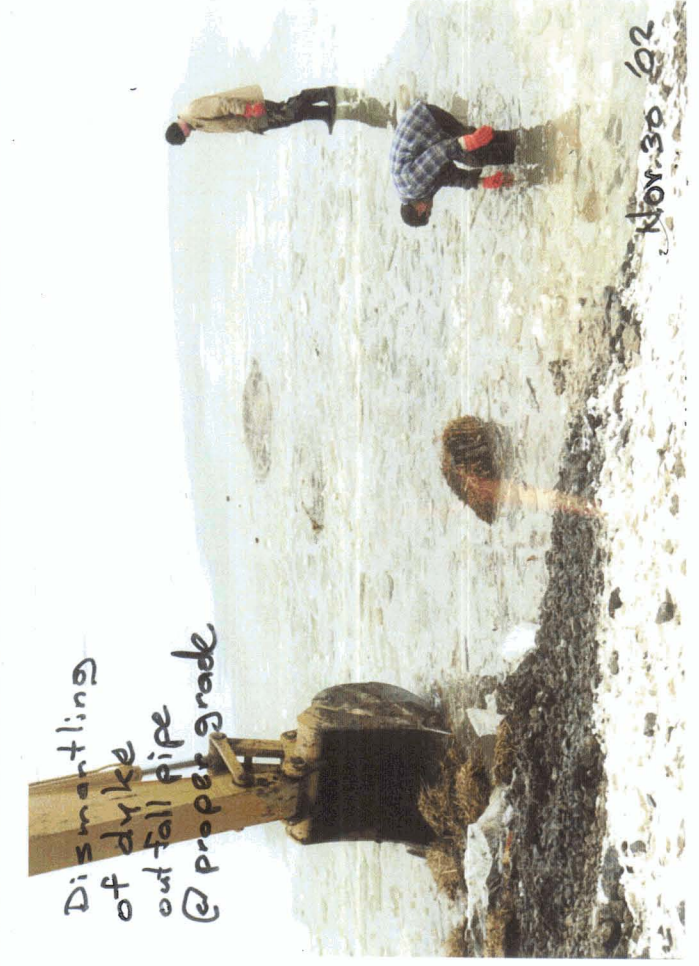
Nov 30 02

Dismantling  
of dyke  
outfall pipe  
@ proper grade
