An earthflow in sensitive Champlain Sea sediments at Lemieux, Ontario, June 20, 1993, and its impact on the South Nation River¹

S.G. EVANS AND G.R. BROOKS

Can. Geotech. J. 31, 384–394 (1994)

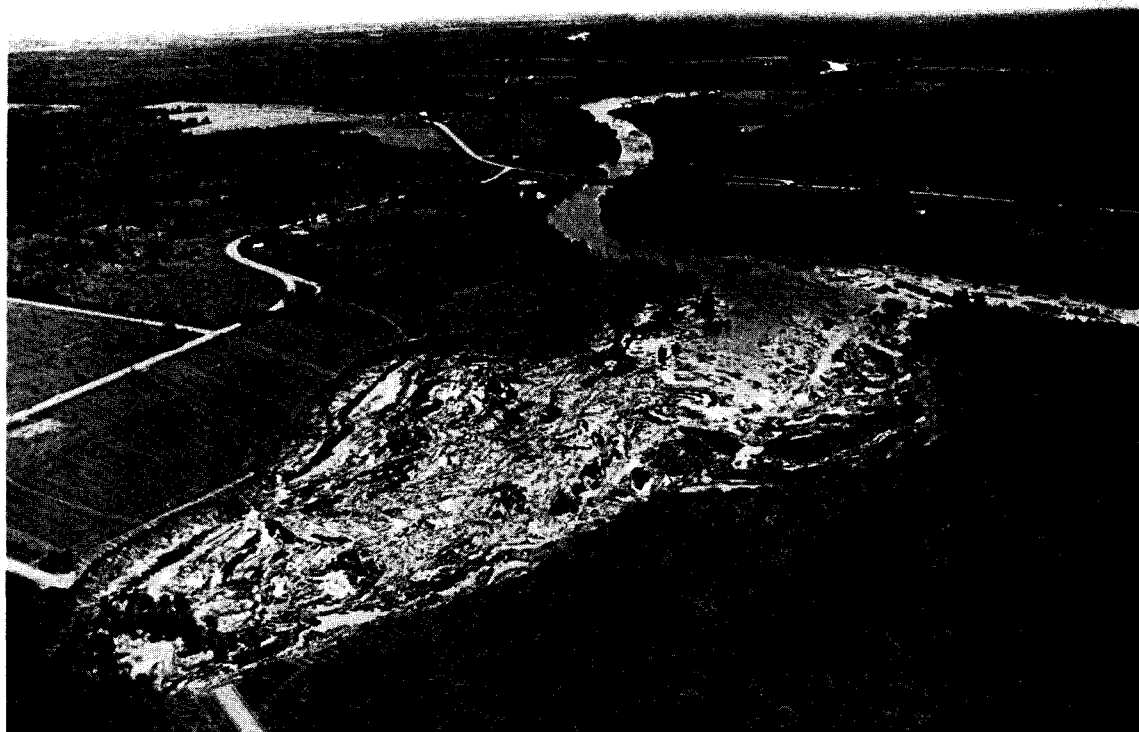
Beginning at approximately 15:30 on 20 June, 1993, a large landslide (Fig. 1), hereafter referred to as the Lemieux landslide, occurred in sensitive Champlain Sea sediments on the east bank of the South Nation River, 0.5 km north of the former townsite of Lemieux, Ontario, 50 km east of Ottawa at 45.4°N, 75.06°W (Fig. 2). The landslide occurred 4.5 km downstream of the well-known 1971 South Nation River landslide (Eden et al. 1971; Mitchell 1978a, 1978b; Mitchell and Markell 1974) (Figs. 2 and 3). The landslide severed County Road 16. A man was injured when he drove his pickup truck into the crater formed by the landslide, and was later rescued by a Canadian Forces helicopter. The statements of eyewitnesses summarized in Brooks et al. (1994) indicate that the major movements of the landslide lasted about an hour and had ceased by about 16:30.

FIG. 1. Aerial view of the 1993 Lemieux landslide which took place on June 20, 1993. View is toward the southwest looking up the South Nation River. Severed County Road 16 is seen at bottom left and County Road 8 bridge discussed in text is seen upstream of the landslide in the middle distance. Note impoundment of river and upstream flooding. Photo taken on June 23, 1993.

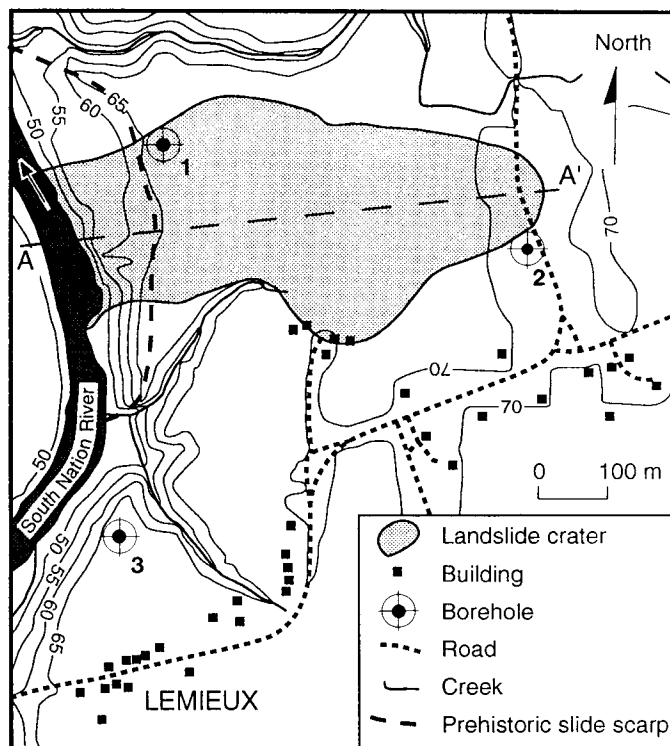
In plan (Figs. 4 and 5), the crater of the 1993 landslide is elongate with a length:width (L:W) ratio of 2.7 and is about 10–12 m in depth at present. Although an unknown thickness of debris covers the floor of the crater, the spoil is at least 12 m deep in the South Nation River channel immediately below the scar. In the absence of postlandslide borings the depth of the failure can only be estimated. From field evidence and information from borings summarized below, the minimum average depth is estimated to be 18 m, varying from 23 m depth at the river to about 13 m at the head of the crater. The maximum retrogressive distance from the South Nation River is 680 m and 555 m from the headscarp of the previous retrogressive sliding. The mouth of the crater is not of the bottleneck type, although there is a slight narrowing of the neck at the river (Figs. 1 and 5). The margins of the slide appear to have been constrained by gullies.

FIG. 4. Map showing the extent of the 1993 Lemieux earth-flow, area of prelandslide retrogressive sliding adjacent to the South Nation River channel, and locations of boreholes drilled in the late 1980s. A–A' is line of section in Fig. 8. Map shows the location of buildings before 1989–1990 buyout. Contour interval is 5 m. Modified from Province of Ontario 1 : 10 000 map 10-18-4950-50250.

A band of inactive retrogressive sliding, about 100–130 m in width, formed the valley side at the location of the landslide (Fig. 4) (Richard 1982). A partial cross section through the slide complex is now exposed in the north wall of the crater mouth. The 1993 landslide was probably triggered

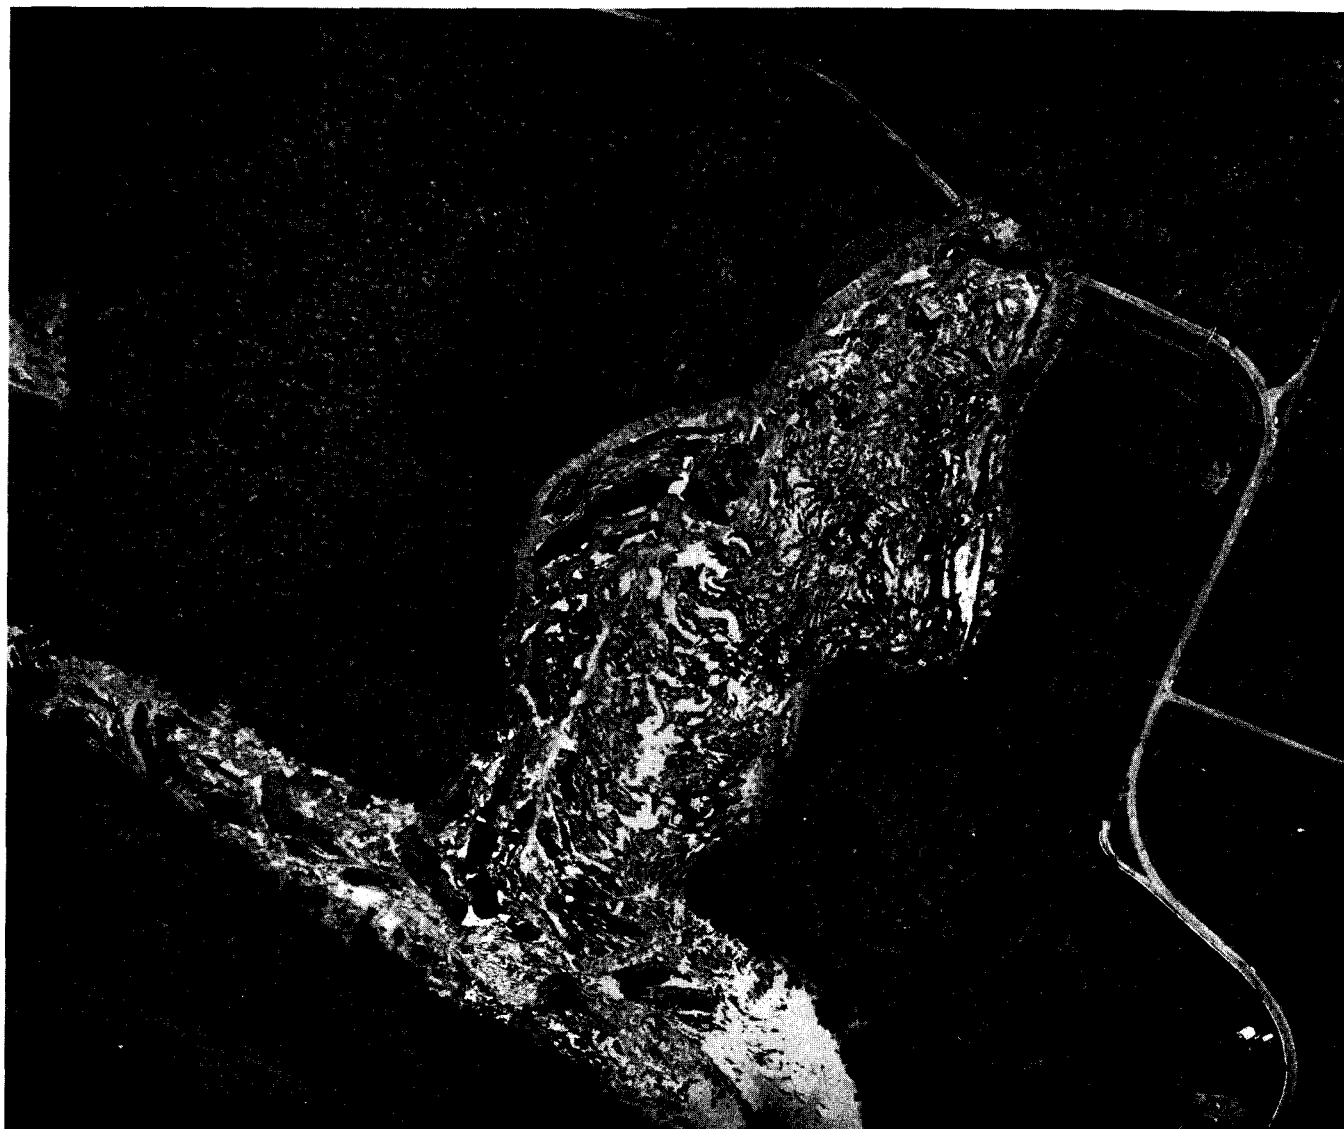
About $1.5 \times 10^6 \text{ m}^3$ of the debris evacuated the crater and flowed into the South Nation River (Fig. 5).

FIG. 5. Vertical aerial photograph of the 1993 Lemieux landslide taken on June 22, 1993 (courtesy of South Nation River Conservation Authority). Direction of flow of South Nation River is shown by arrows. Scale is approximate.

From aerial photography taken on June 22, the landslide deposit ranges in width from 120 to 160 m in the area immediately opposite the crater mouth (Fig. 5). This width occurs because the debris crossed the valley bottom and buried a terrace along the opposite side of the valley. Towards the downstream end, the deposit narrows to about 50 m where it is confined entirely within the South Nation River channel

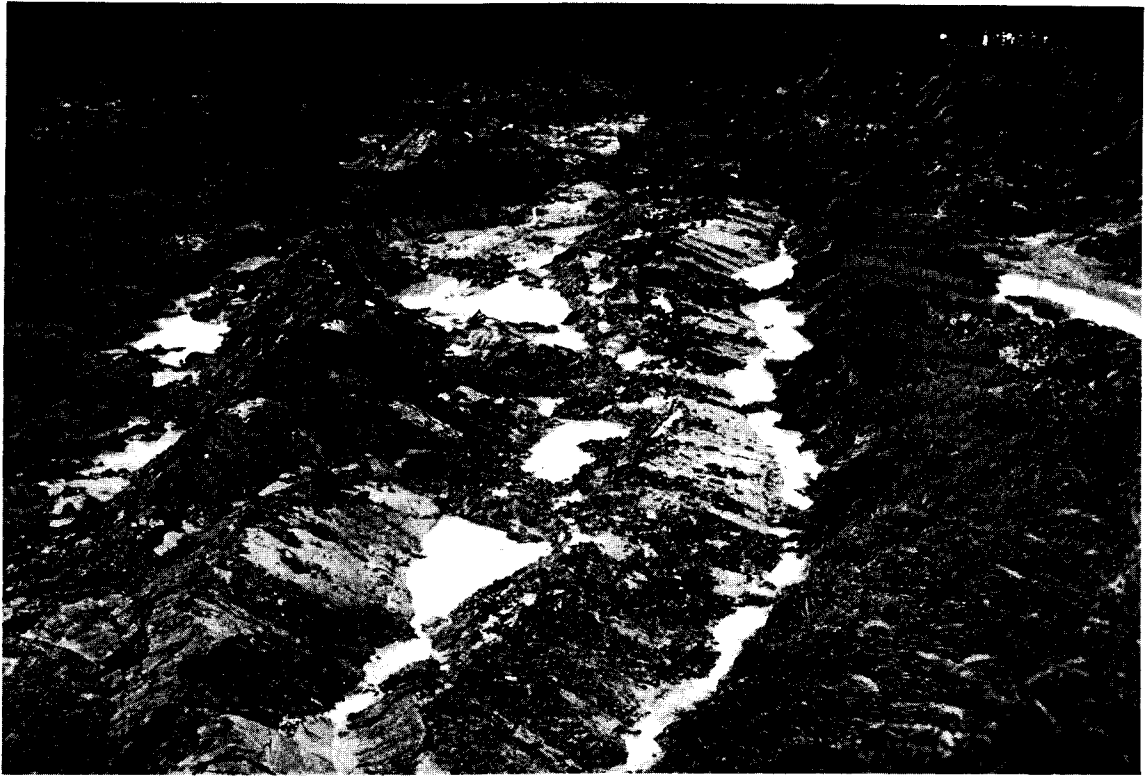
Within the crater, grounded, prismatic-shaped blocks are found in a mass of remoulded spoil at various locations (Figs. 6 and 7) including near the crater mouth. Within these blocks, laminations are horizontal, or near horizontal, in attitude. In addition, in the areas of the debris nearest the crater margin, contiguous sharp-crested ridges, about 3 m in height and consisting of blue-grey laminated silts and sands, parallel the sides of the crater (Figs. 5 and 6). As in the case of the individual blocks the laminations exposed in these ridges are invariably horizontal, or near horizontal, in attitude and the fact that the sediments are lower than their original position in the crater side indicates that translation has been accompanied by some subsidence. Rafts of sod are also present in the crater (Fig. 5), some with trees still standing upright in their growing position. Rotated blocks are also evident in the debris, particularly around the margins of

FIG. 6. The Lemieux landslide crater on June 21, 1993, about 24 h after the landslide took place. View is to the east along the south rim where onlookers (top right) provide scale. Note (from right to left) rotational blocks below the scarp, an exposed sliding surface within displaced blocks which formed along rotated lamination surfaces, clay ridges about 3 m in height, and sod from former field surface, and another clay ridge. Laminations in the clay ridges are horizontal.

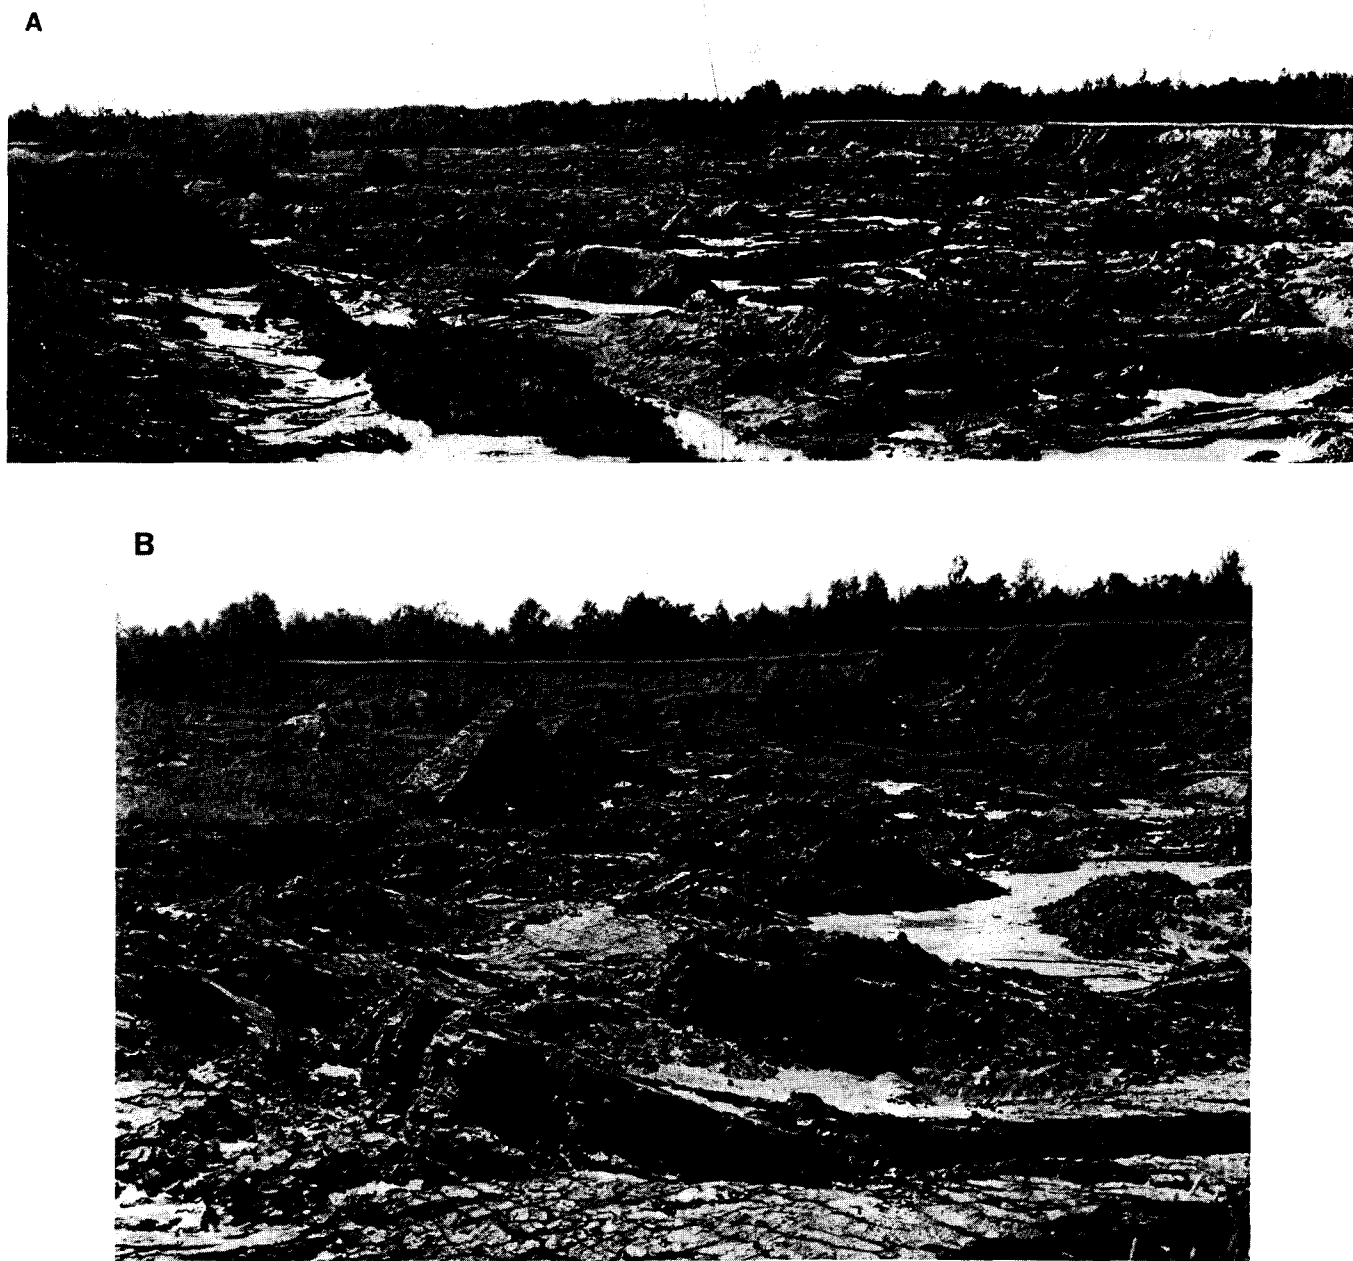
the crater (Fig. 6). They are also found in the vicinity of the prismatic blocks, where they have appeared not only to have rotated and sunk into the remoulded spoil, but have been subject to disintegration by sliding along laminations in response to the rotation (Fig. 7).

The morphology of the debris is therefore consistent with a mechanism that involves the break up of a stiffer cap and the subsidence and transport of the cap blocks in a mass of remoulded spoil, much of which flowed out of the crater into the valley of the South Nation River.

FIG. 7. (A) View to the west toward the mouth of the crater of debris and intact blocks. Scarp at left is approximately 9 m high. Arrowed pyramidal block is that shown in (B) (photograph courtesy of J.M. Aylsworth, taken on September 21 1993, 3 months after the landslide). (B) Grounded prismatic blocks, rotated blocks, and remoulded spoil in the centre of the crater. Pyramidal block to right of person is that arrowed in (A). View is toward the north rim. Photograph taken July 7, 1993.

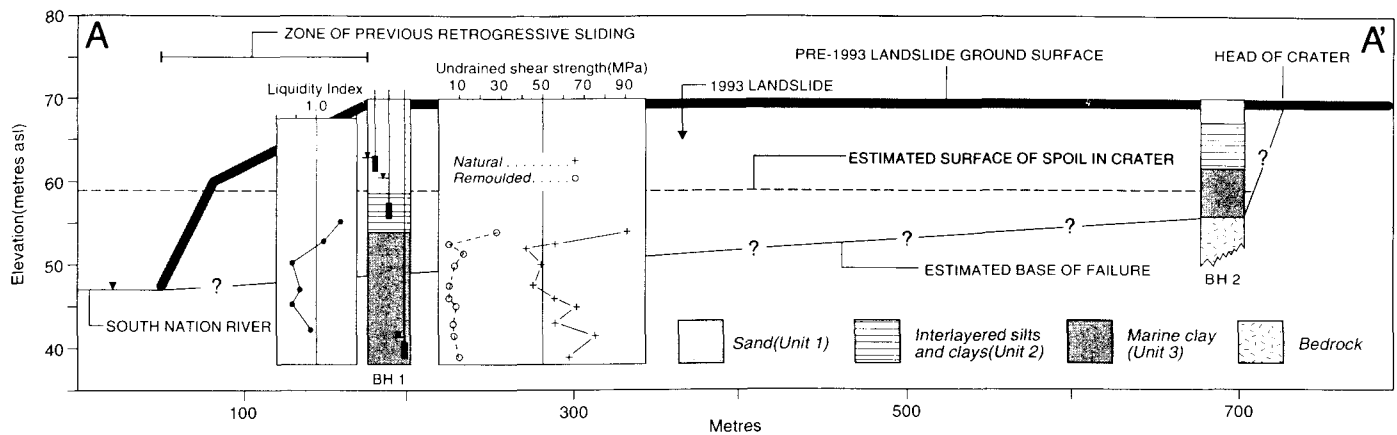
Stratigraphic and geotechnical data for the landslide site are available from the three boreholes (located in Fig. 4), which had been drilled in 1986 by the Ontario Ministry of Natural Resources (borehole 2) and in 1987 by Golder Associates (boreholes 1 and 3). In broad outline the stratigraphy of the site consists of three units (Fig. 8; Table 1) that coarsen upward, consistent with emergent conditions

Subsurface stratigraphical and geotechnical data (Fig. 8; Table 1), therefore, indicate the presence of a lower unit of soft marine clay overlain by a stronger, stiffer cap consisting of the grey-blue laminated interbedded sands and silts and the overlying brown silty sand. In the middle to lower part of the marine clay unit, values of I_L in excess of 1 indicate that the unit is very sensitive to remoulding. Field vane tests measured high sensitivities (>4) in the upper part of the unit at a location that corresponds to the base of the landslide. This evidence suggests that the Lemieux landslide occurred as a result of strength loss in a sensitive clay zone located between 8 and 23 m beneath the surface and that the liquefaction of most of the slide mass beneath the stiffer cap was due to its high liquidity index ($I_L > 1$).

FIG. 8. Approximate cross section (A-A' in Fig. 4) and geotechnical profile of Lemieux landslide based on drilling carried out in 1986 and 1987. Vertical exaggeration is five times horizontal. Boreholes (BH) projected onto cross section. Data in borehole 1 provided by Golder Associates.

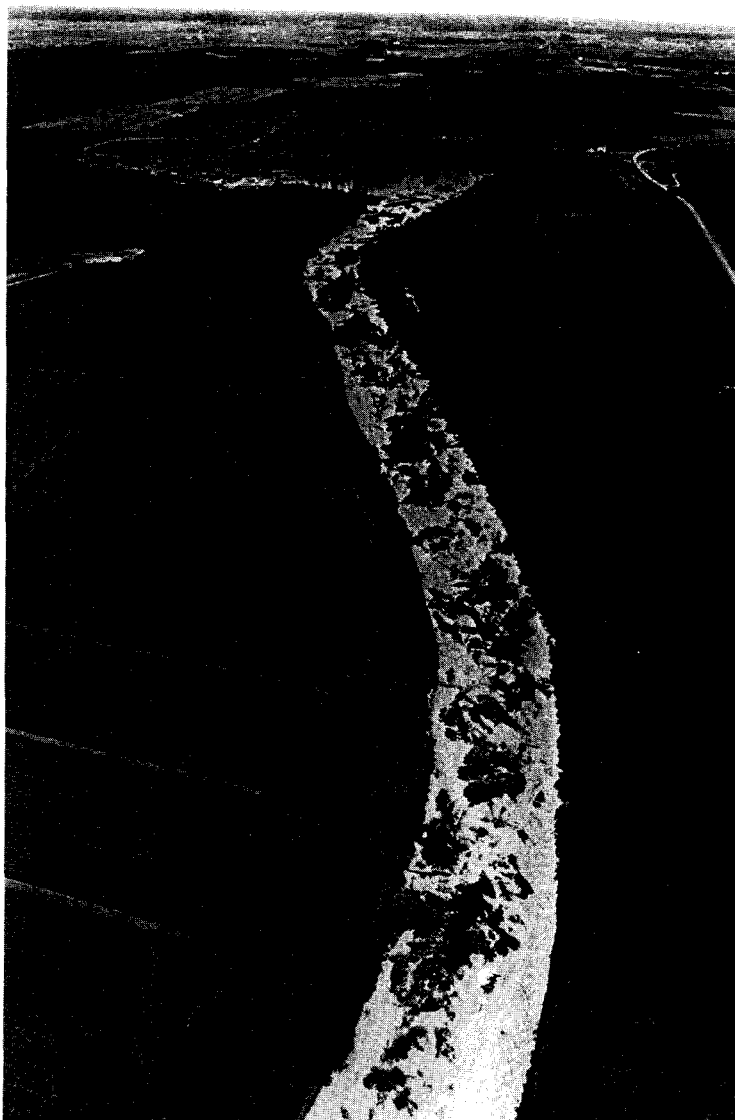
FIG. 9. Aerial view of landslide debris in the channel of the South Nation River downstream of landslide crater, which is visible at top left. Photograph taken on June 23, 1993.

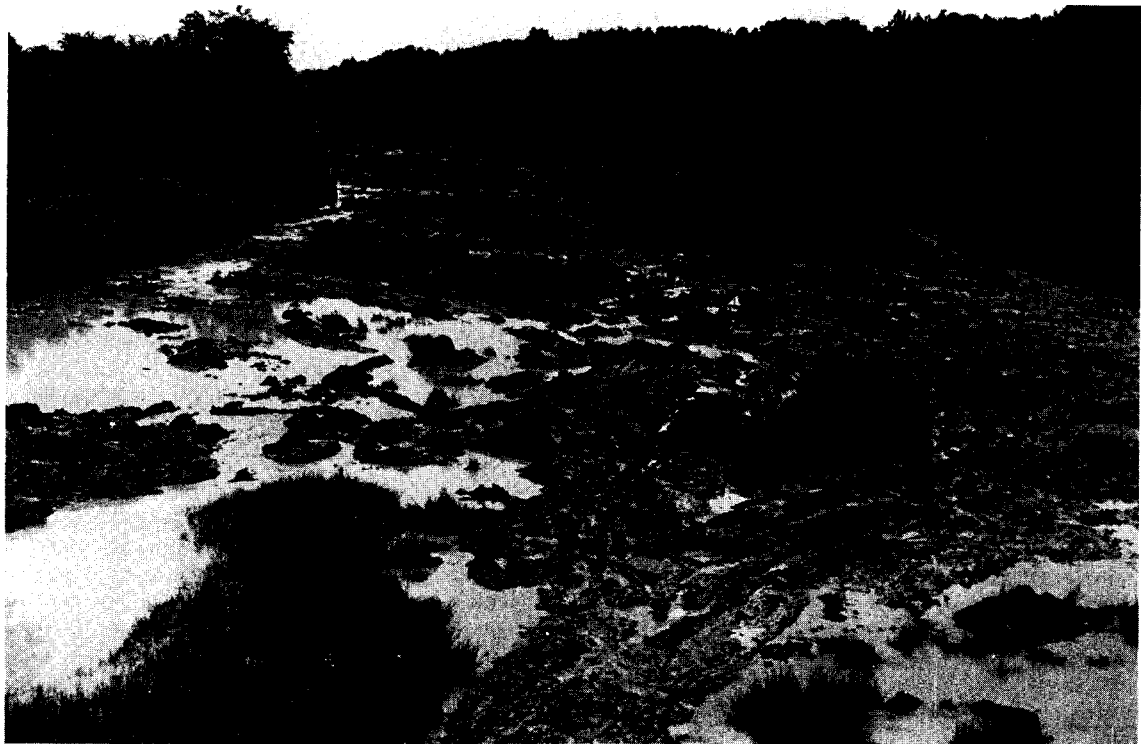
FIG. 10. Landslide debris consisting of remoulded spoil and clay blocks in the channel of the South Nation River upstream of landslide crater. Photograph taken on June 21, 1993, from County Road 8 bridge (see Fig. 1) looking upstream.

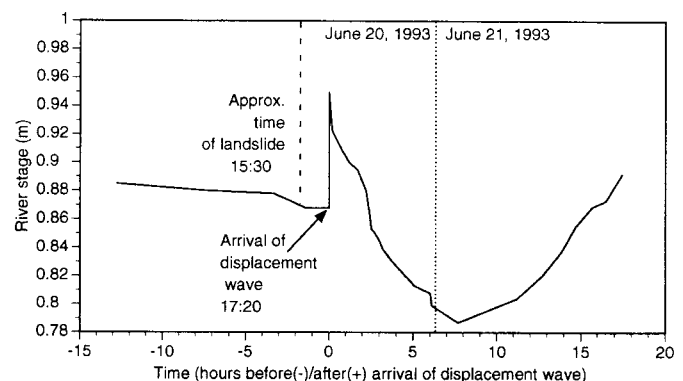
The impoundment of the South Nation River by the landslide debris is apparent in the discharge record at the Plantagenet Springs station (Fig. 11), but the flow was not affected severely. Over the course of Sunday, June 20, 1993, the river stage had been falling gently (Fig. 11). At the time of the landslide (15:30) the stage was 0.868 m, equivalent to a discharge of about 22.4 m³/s (Fig. 11). At 17:20, the stage rose abruptly by 0.082 m. As noted above this is believed to represent a wave of water displaced downstream by the landslide as it surged along the South Nation valley bottom.

Immediately after the rise, the stage fell by about 0.028 m, then continued to decrease more slowly, attaining its pre-wave level at 19:40. The 2.33 h period between the rise and fall stage reflects the very slight gradient of the river channel (D. Rowe, personal communication, 30 June 1993) and severe dampening of the wave by the channel bottom over the 28.4 km distance from the landslide to the stage recorder.

From 19:40 to 01:00 on June 21, the river stage continued to fall, eventually reaching 0.787 m (or a discharge of 11.9 m³/s), reflecting the impoundment of the river by the landslide. After 01:00 on June 21 the flow increased in response to heavy precipitation falling within the watershed (Fig. 11).

FIG. 11. River level at the Plantagenet stage recorder, 28.4 km downstream of the landslide. The water surface of the South Nation River rose abruptly by 0.082 m at 17:20 June 20 (110 min after the beginning of the landslide) in response to a displacement wave generated by landslide debris flowing down the South Nation valley. After passage of this wave, stage fell gradually to 0.787 m, reflecting the impoundment of the river by the landslide debris. The rise in stage, beginning after 01:00 June 21, reflects rainfall being routed through those areas of the watershed unimpeded by the landslide (data courtesy of Environment Canada).
