GEOLOGICAL SURVEY OF CANADA
MISCELLANEOUS REPORT 56

**The Lemieux landslide of June 20, 1993,
South Nation Valley, southeastern Ontario –
a photographic record**

G.R. Brooks, J.M. Aylsworth, S.G. Evans, and D.E. Lawrence

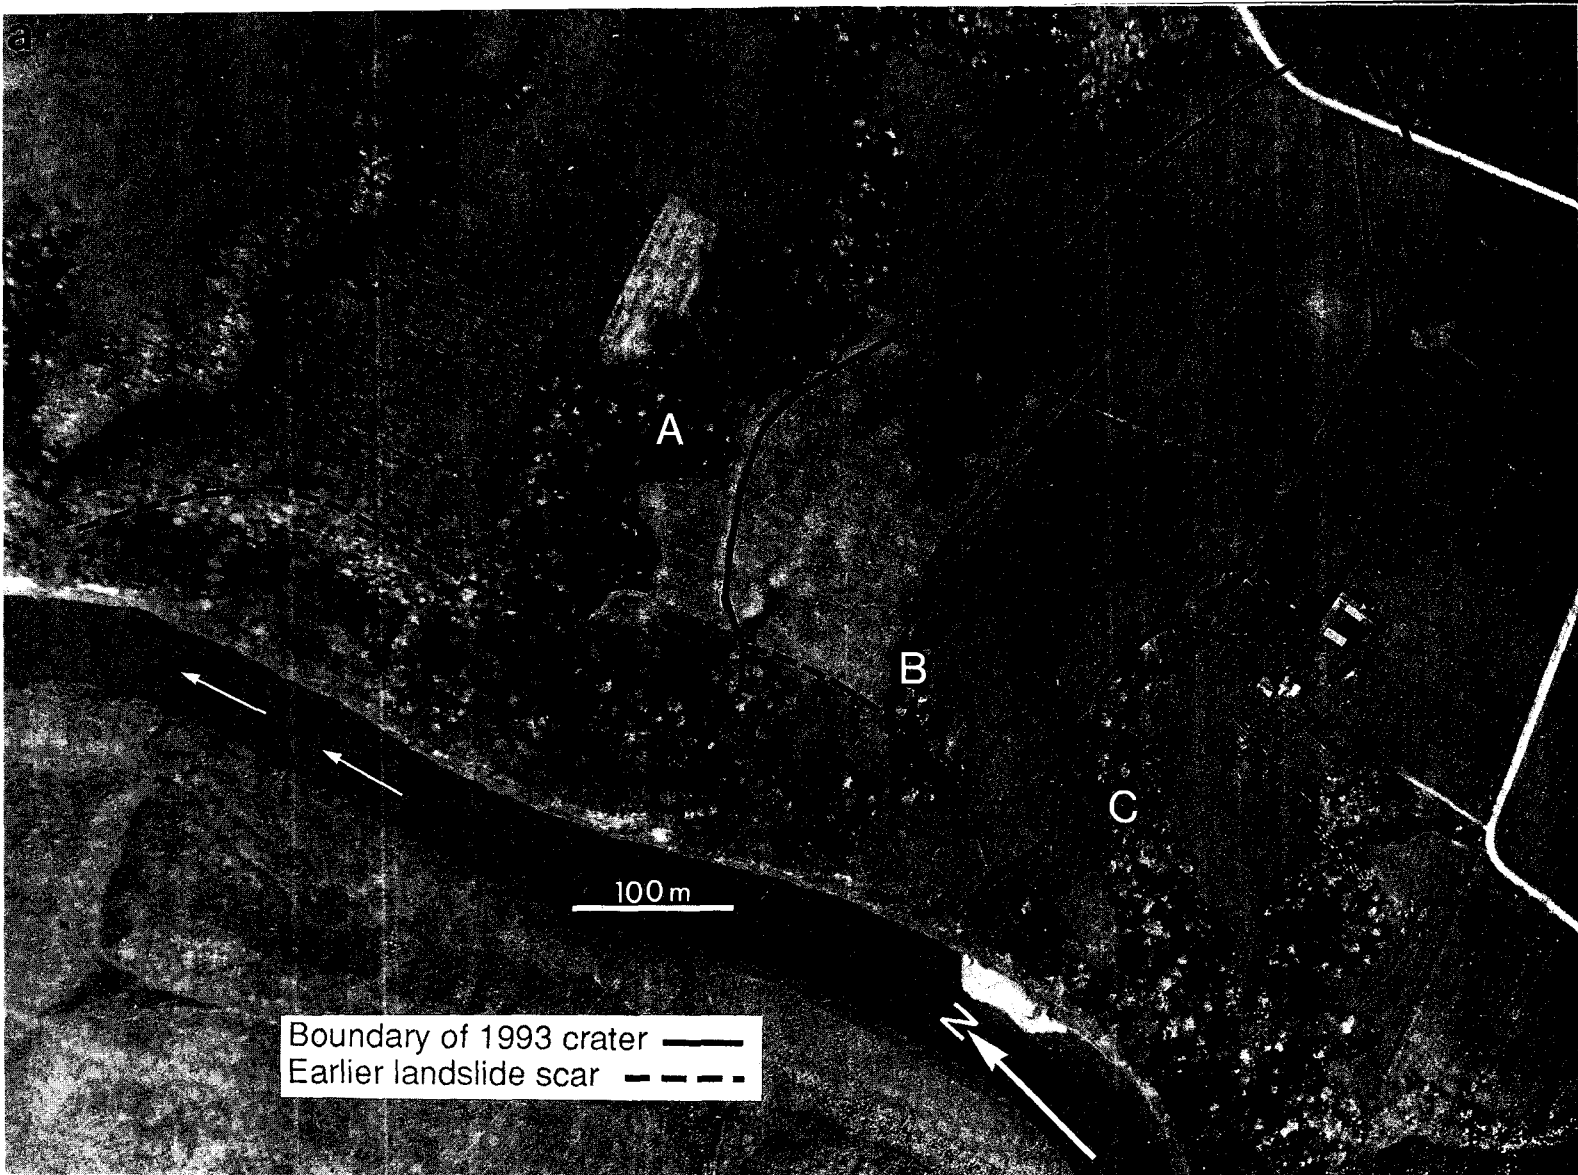
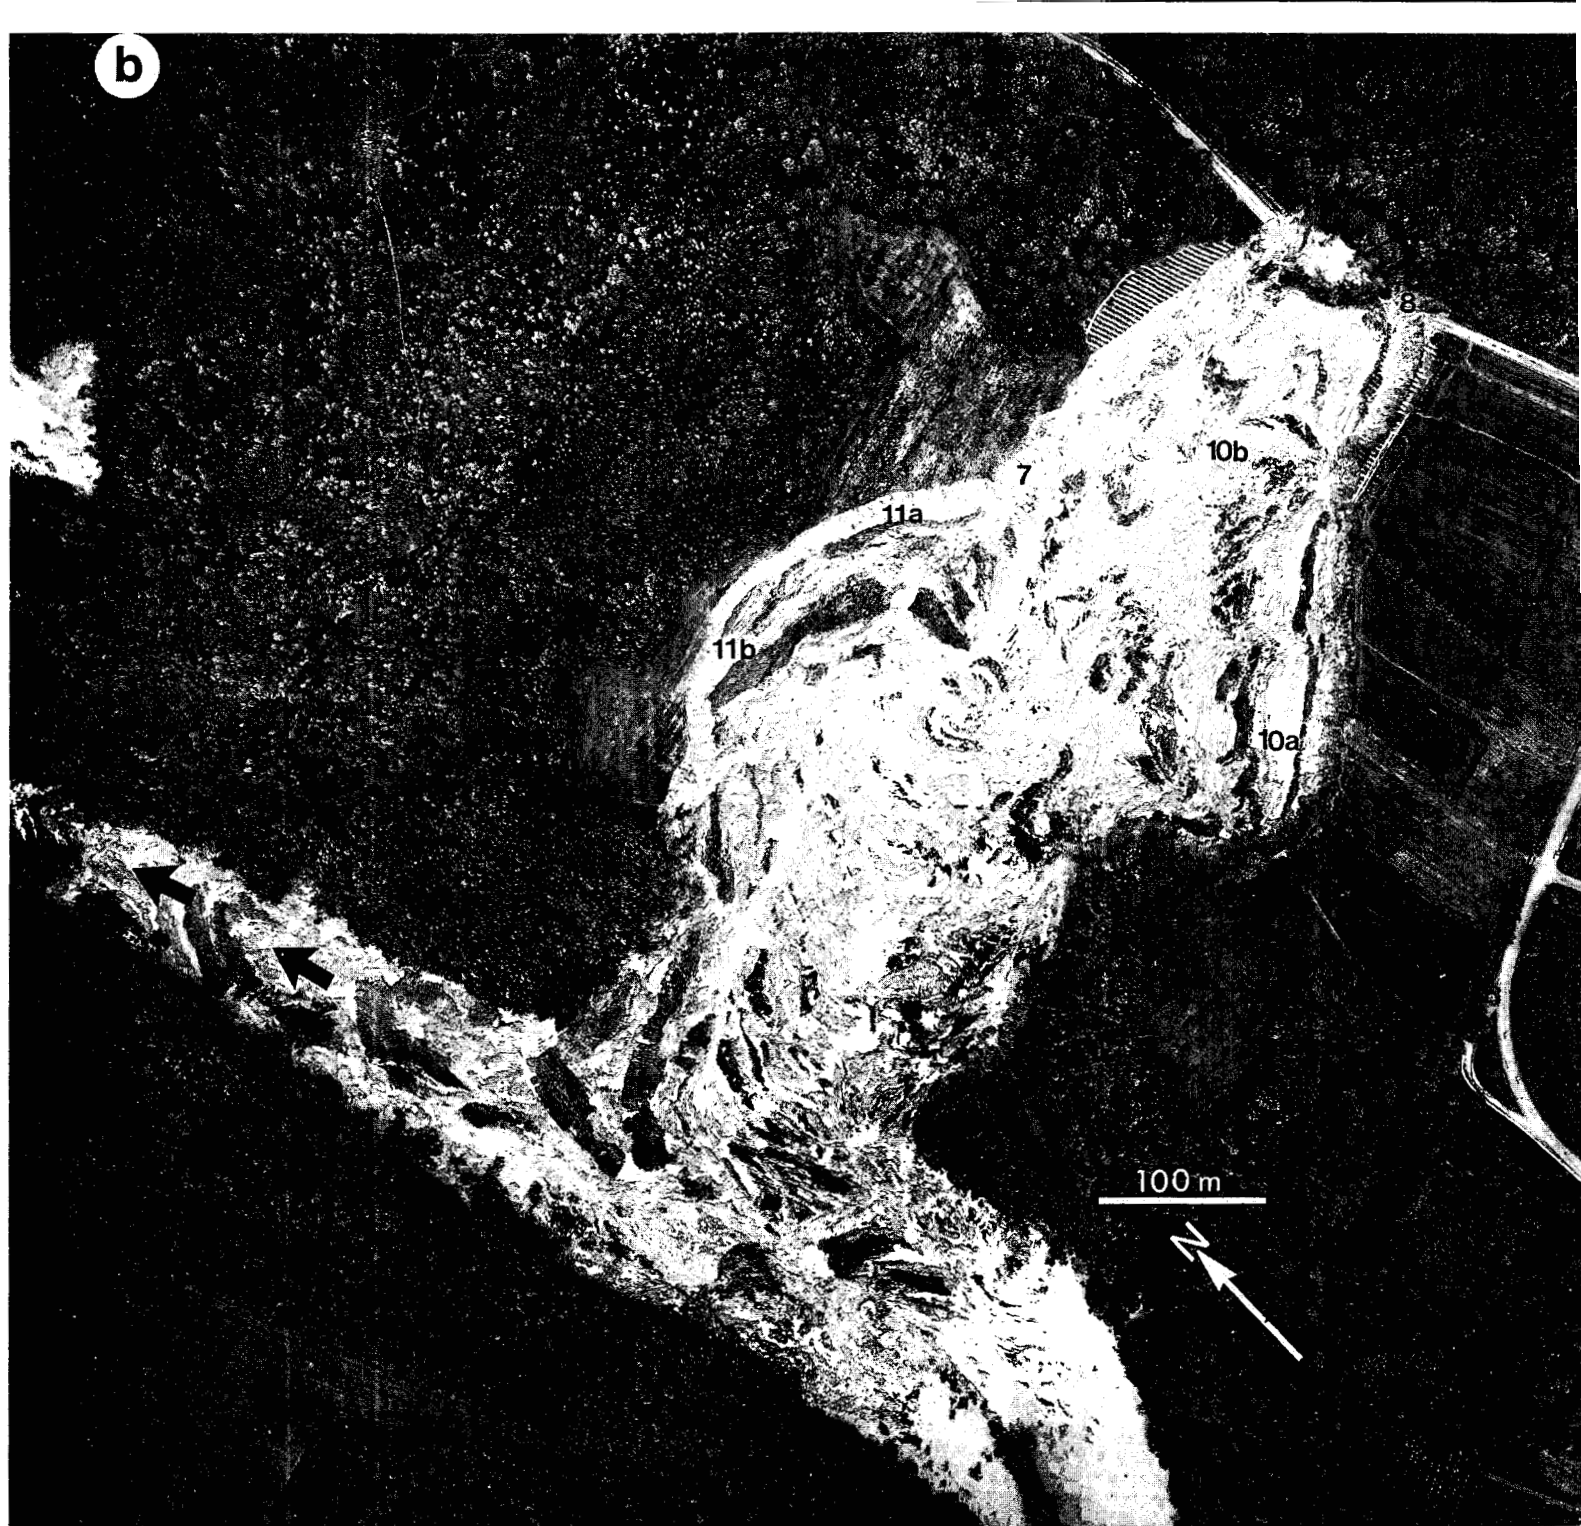
Figure 2. Aerial photographs of the Lemieux site *a)* pre-slide (November 21, 1945; NAPL A9615-91) and *b)* post-slide (June 22, 1993; CAS 93049-13). This site is along a straight section of South Nation Valley just downstream of the outer bank of a bend (Fig. 1). The 1993 landslide occurred at the site of an earlier retrogressive slide scar; a dashed line delineates the backwall of the earlier scar. This scar forms a terrace along the valley side about 15 m above the pre-slide river channel. Most of the failed area was abandoned farmland with some mixed forest. The failure occurred between two gullies extending eastward from the valley side (A and C). A smaller gully (B) located between these gullies was obliterated by the landslide. The extent of the failure seems to have been restricted by the presence of gully C since the crater roughly follows the upper edge of the gully then begins to curve around behind it (Fig. 2b). The presence of this gully probably allowed sufficient drainage of the immediate area to prevent failure. Note the river bar that coincides approximately with the upstream lip of the crater mouth; it appears on maps and aerial photographs of the site beginning at least in the 1940s.

Photo b) was taken two days after the landslide and before the impounded river had overtopped the spoil in South Nation Valley. The landslide crater is 680 m long and up to 320 m wide, covering 17 ha (Evans and Brooks, in press). The elongated shape is not symmetrical; outward embayments extend from both its north and south side. Numbers refer to location of Figures 7, 8, 10a, 10b, 11a, 11b.

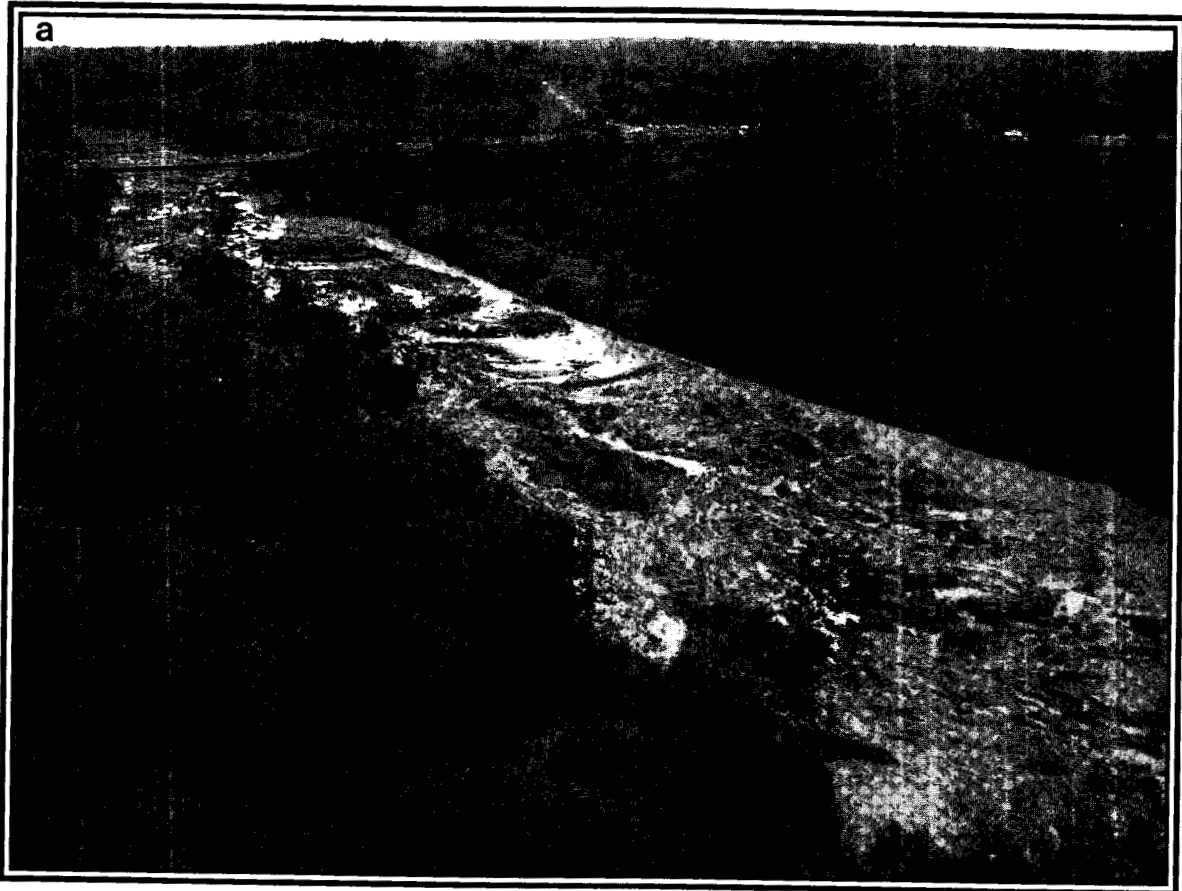
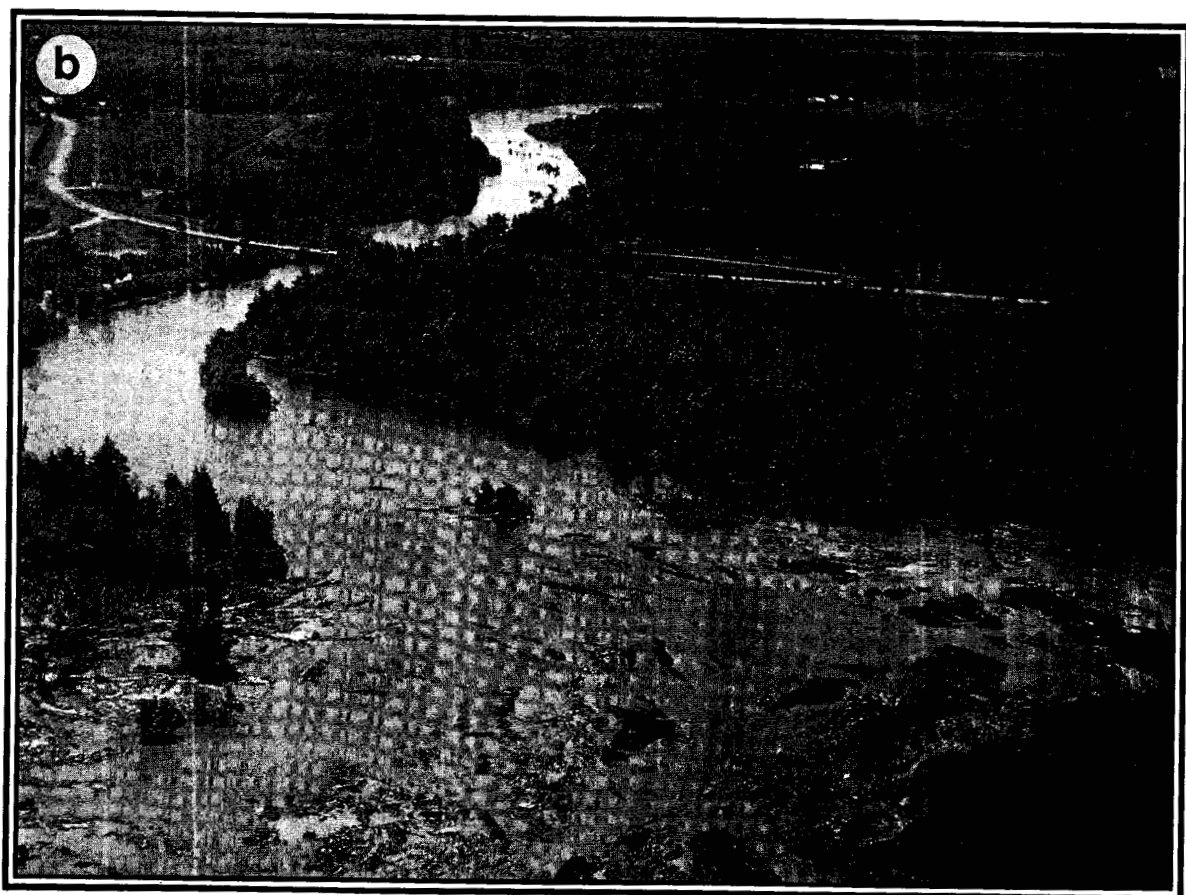
Figure 4. a) Landslide spoil, consisting of rafted blocks of relatively intact material within a matrix of liquefied clay and silt, buried the valley bottom extending about 1.6 km upstream and 1.7 km downstream of the crater mouth. This view is looking downstream towards the County Road 8 bridge which crosses South Nation River about 800 m upstream of the crater, and shows spoil which flowed upstream along the valley bottom. At the bridge, spoil filled the valley to an estimated depth of about 12 m. (photo Ottawa Citizen) **b)** The accumulation of spoil within South Nation Valley impounded the river upstream of the crater. Immediately after the landslide, river waters rose until they eventually overtopped the spoil. The impounded water reached a maximum height of about 12 m above the pre-slide valley bottom which caused flooding upstream as far as Casselman, Ontario (Fig. 1). This photograph was taken late morning Wednesday, June 23, 1993 at approximately the maximum height of the river impoundment and is looking across the crater mouth upstream into the flooded South Nation Valley (GSC 1993-254B).

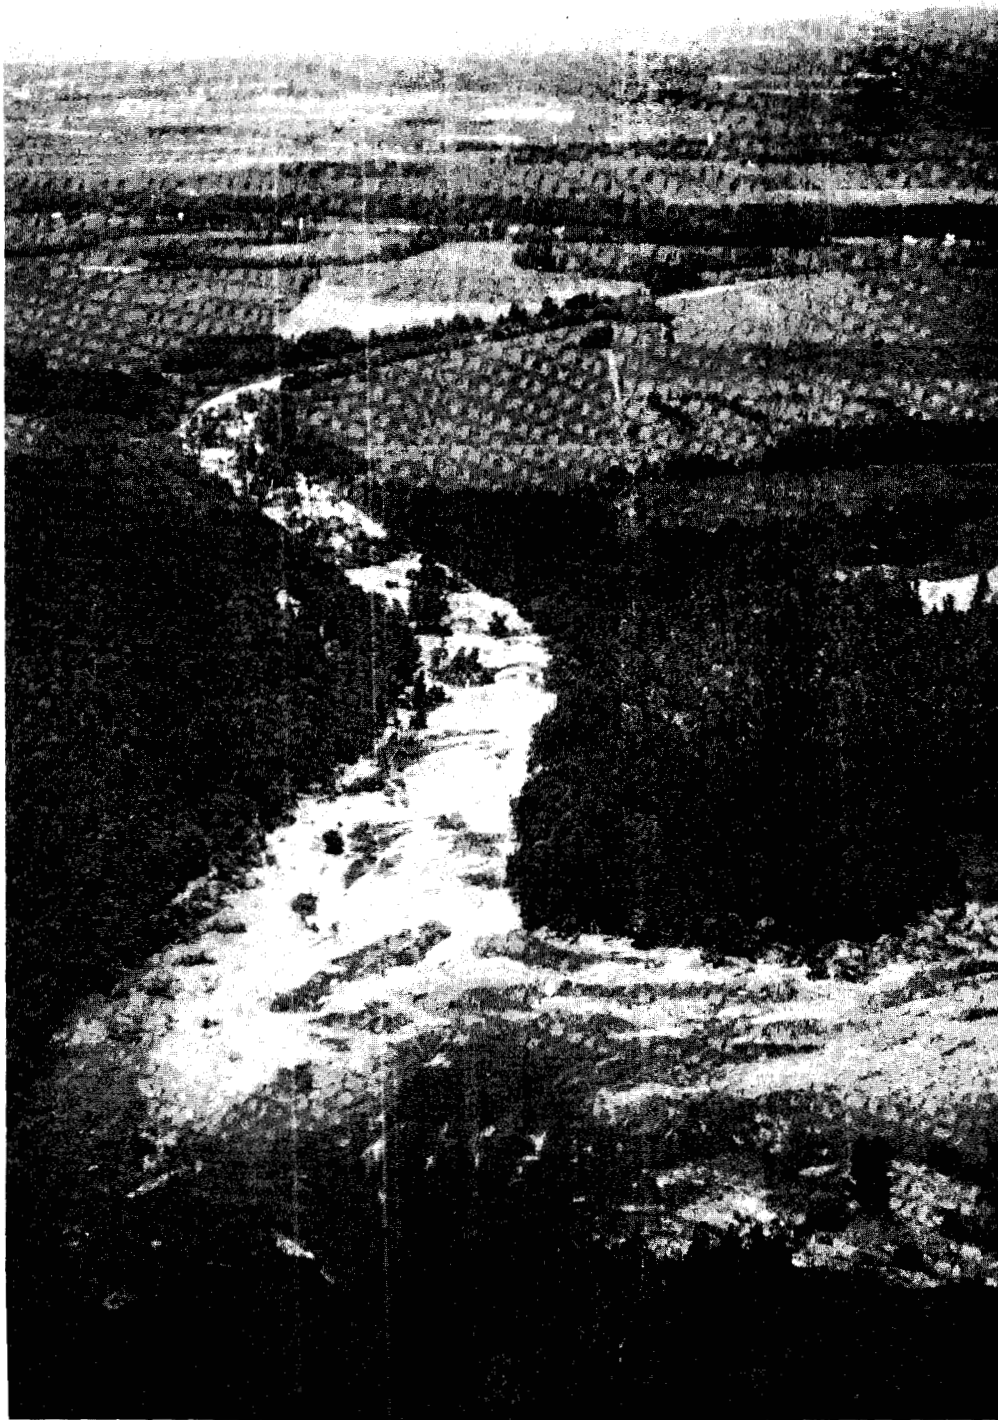
Figure 5. View downstream across the crater mouth showing the landslide spoil which travelled downstream along the valley bottom (GSC 1993-254A). It was taken late morning Wednesday, June 23, 1993, hours after the impounded river waters overtopped the landslide dam and began flowing downstream. Reflecting a rapid change in water turbidity, water colour changes from dark to light beginning at the mouth of the crater where flow starts to accelerate across the crest of the landslide dam causing erosion and entrainment of the spoil. High levels of water turbidity adversely affected water quality to farms and communities downstream for several days after the river flow was restored.

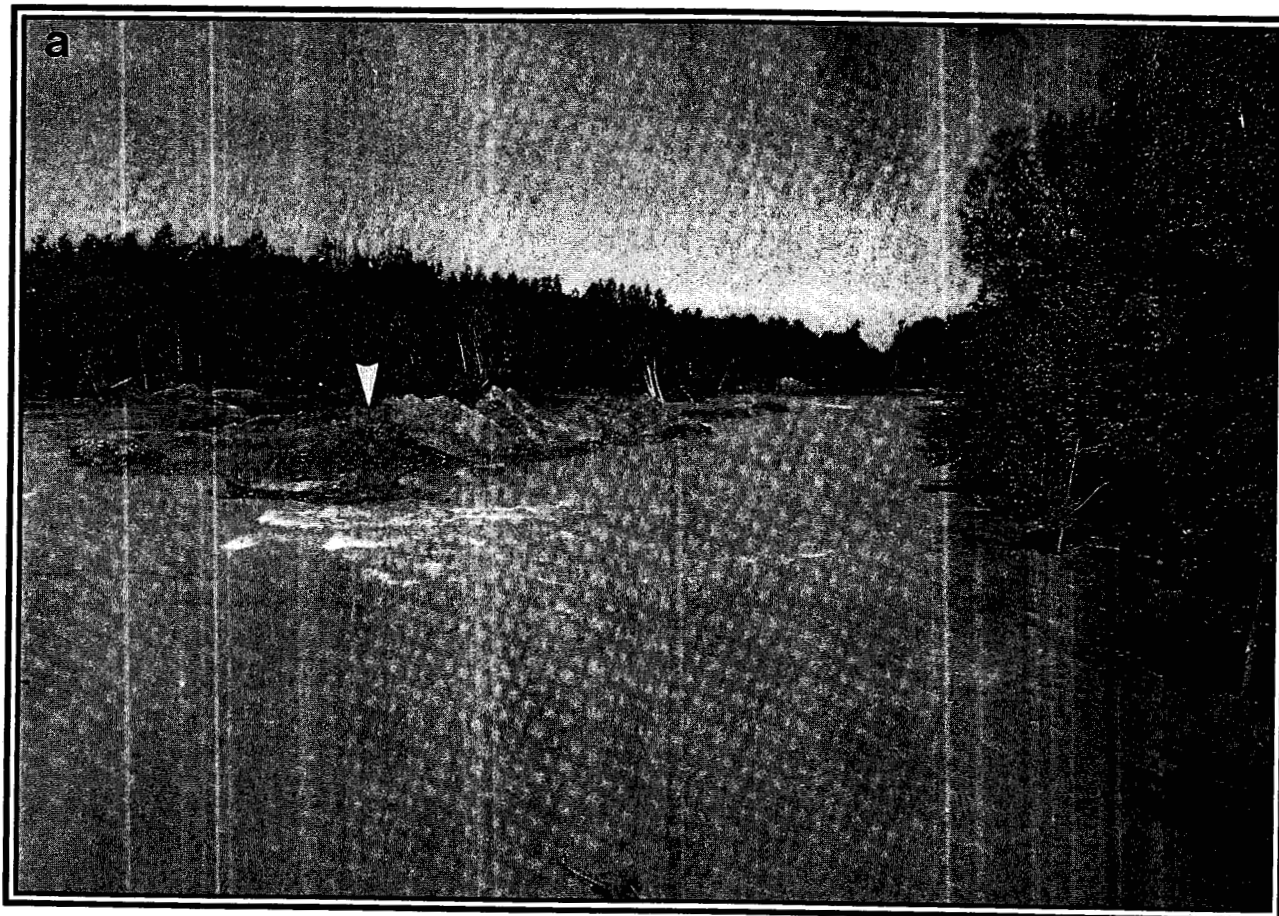
Figure 6. After the overtopping of the landslide dam, the restored flow of South Nation River occurred initially as a broad sheet subdivided by intact sediment blocks and rafted vegetation (cf., Fig. 5). The river gradually incised the spoil (2 m by July 7), reducing the level of the impoundment and creating a relatively narrow, sinuous channel. Comparative photographs of the river reach looking downstream immediately below the lower lip of the crater mouth reveal this change: **a)** taken early afternoon Thursday June 24, 1993 before significant incision (GSC 1993-254I) and **b)** October 11, 1993 after about 5 m of incision. The photographs are taken from the same position; arrows in **a)** and **b)** depict a common prominent ridge. (GSC 1993-306)

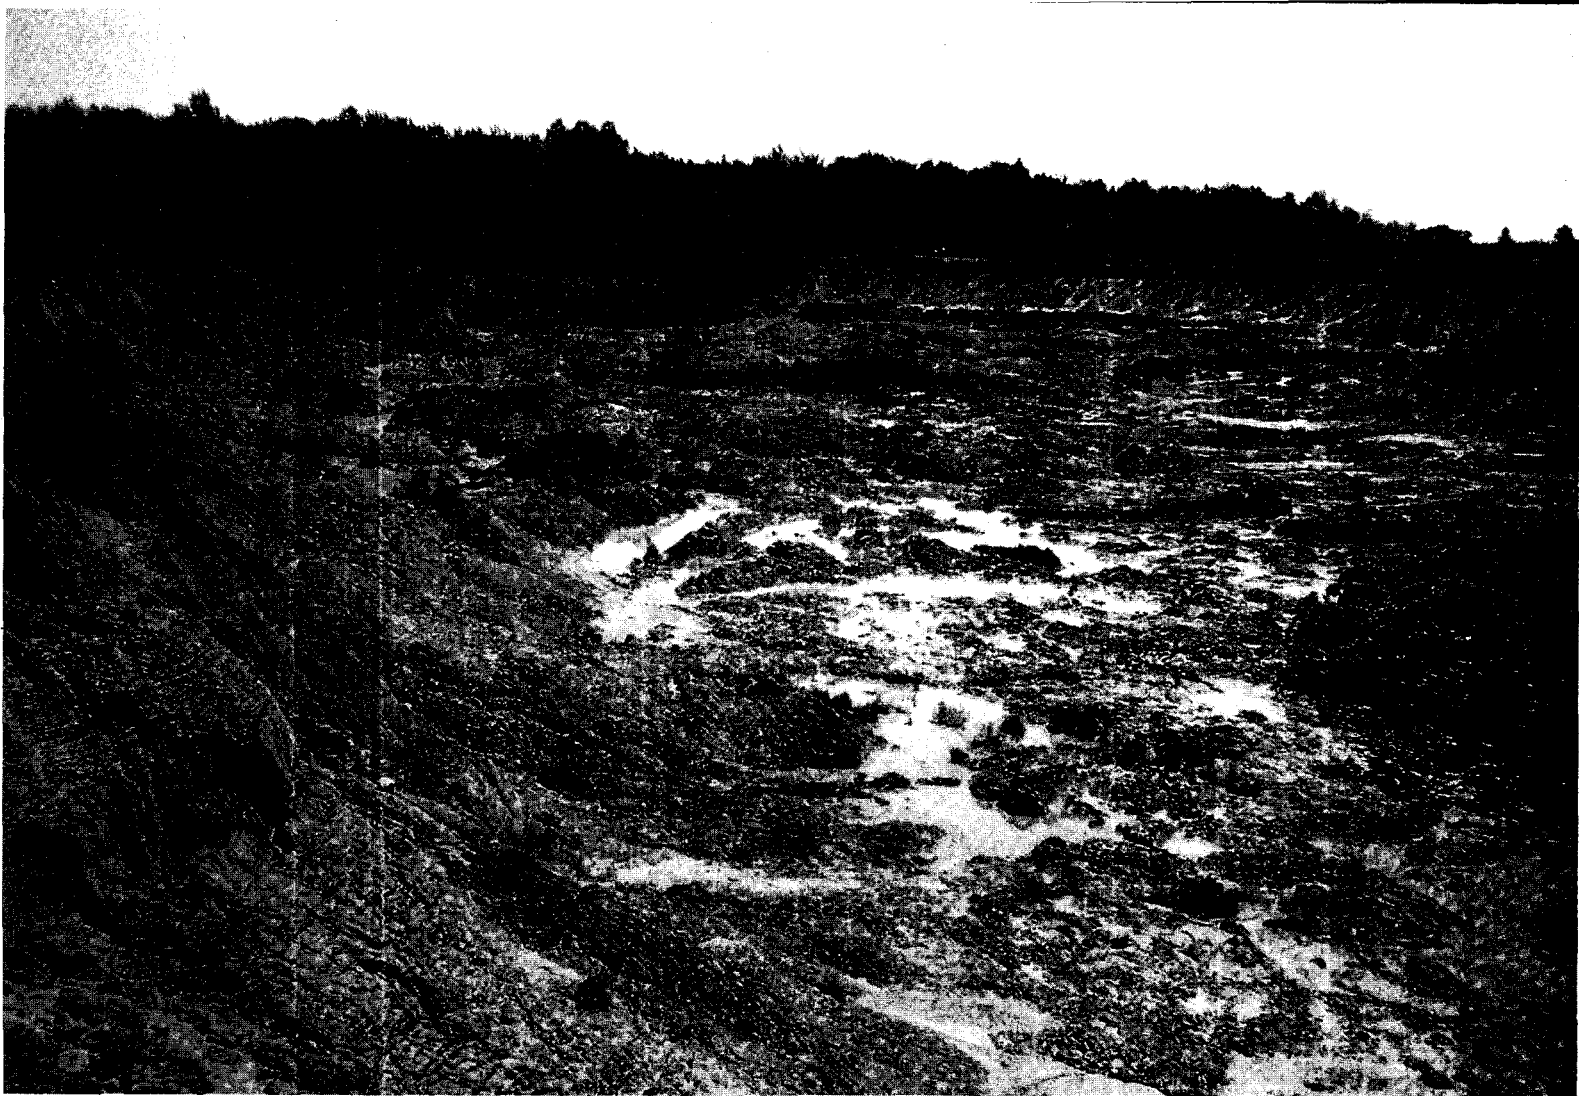
Figure 7. View along north sidewall towards the headwall. Along the reach of South Nation Valley prone to landslides, glaciomarine sediments (silts and clays) are buried beneath deltaic sands. The crater walls reveal a sequence of sediment fining downwards from structureless sand, through interbedded silty sand, laminated fine sand/silt with thin clay layers, to laminated clay with thin silt layers. Deposits in the upper part of the sequence did not remold during the landslide, but rather fractured to form blocks rafted within the spoil. For months after the landslide, water seeped from all coarser laminations in the crater walls. GSC 1993-295A

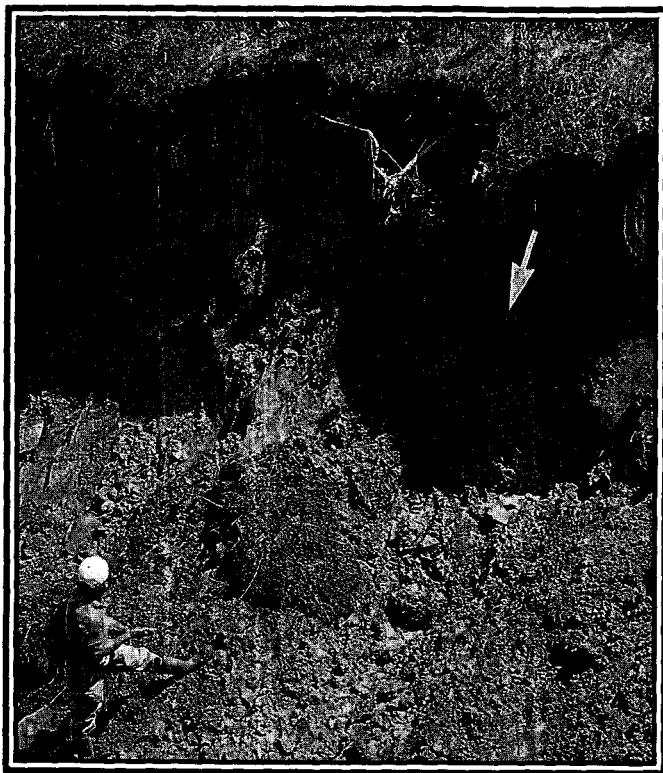
Figure 8. Indicative of the high water table at the time of the landslide, there was widespread standing water and evidence of drainage into the subsoil on the undisturbed surface around the margin of the crater. After the failure, groundwater seeped from the crater sides, with horizontal pipes being eroded at locations of concentrated flow. Pipe diameter ranged from 0.1-1 m and most were located at a depth of about 2.5 m at the sand/silt interface. The pipe in this photograph was located at the headwall of the crater where eighteen active pipes were observed on Thursday, June 24, 1993. Many of these pipes continued to enlarge in diameter and depth over the summer. GSC 1993-295B

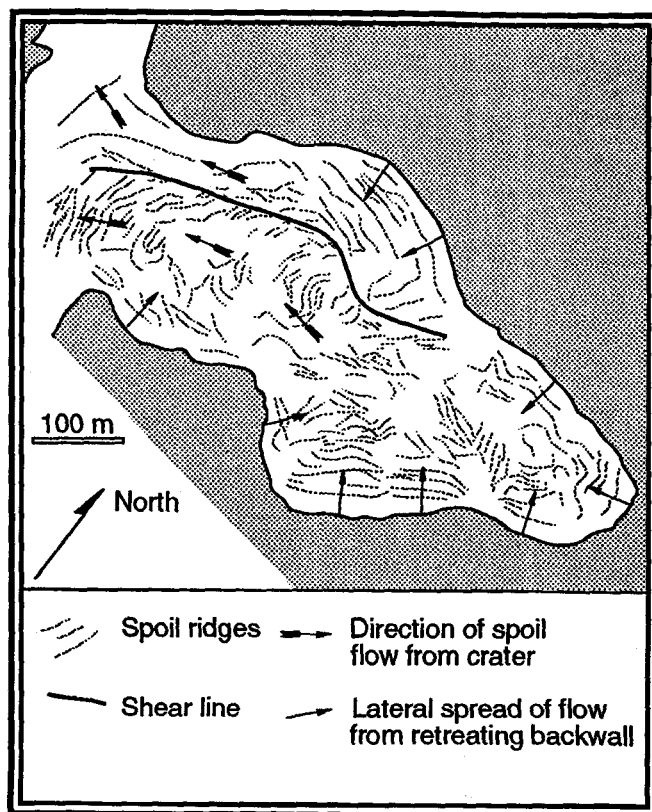
Figure 9. Within the spoil remaining in the crater are blocks of intact sediment and strips of sod and upright trees that form linear ridges within the remolded clay and ponded water (Fig. 2b). The arrangement of the ridges relates to the pattern of backwall retreat, but since much of the spoil has flowed into the river valley, the pattern of retreat probably relates only to the final stage of the landslide. Assuming that the direction of retreat is perpendicular to the ridges, an outline of the ridges reveals that failure generally has occurred along the crater sides obliquely with respect to the long axis of the crater. This pattern of retreat significantly increased the crater width and has contributed to the formation of an embayment on both the north and south side of the crater. In the lower two-thirds of the crater, there is a lineation running up from the river that appears to be a shear-zone between the flow of spoil in the central portion of the crater and that flowing from the north side embayment.

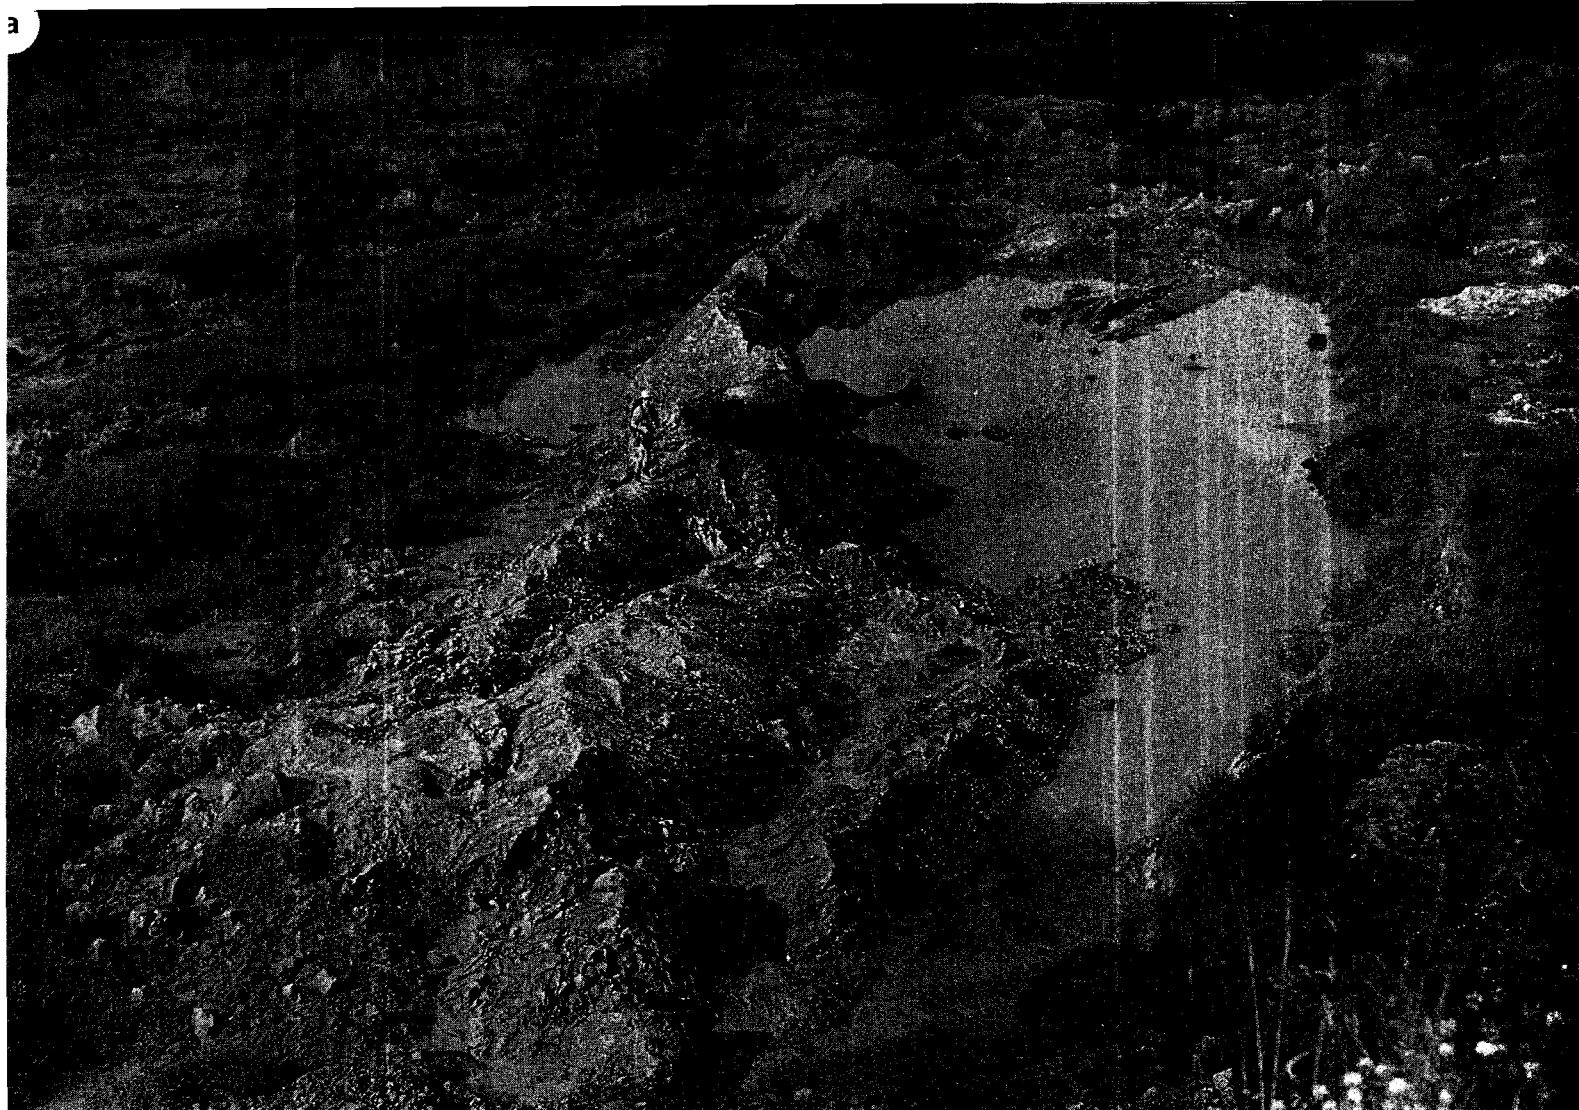
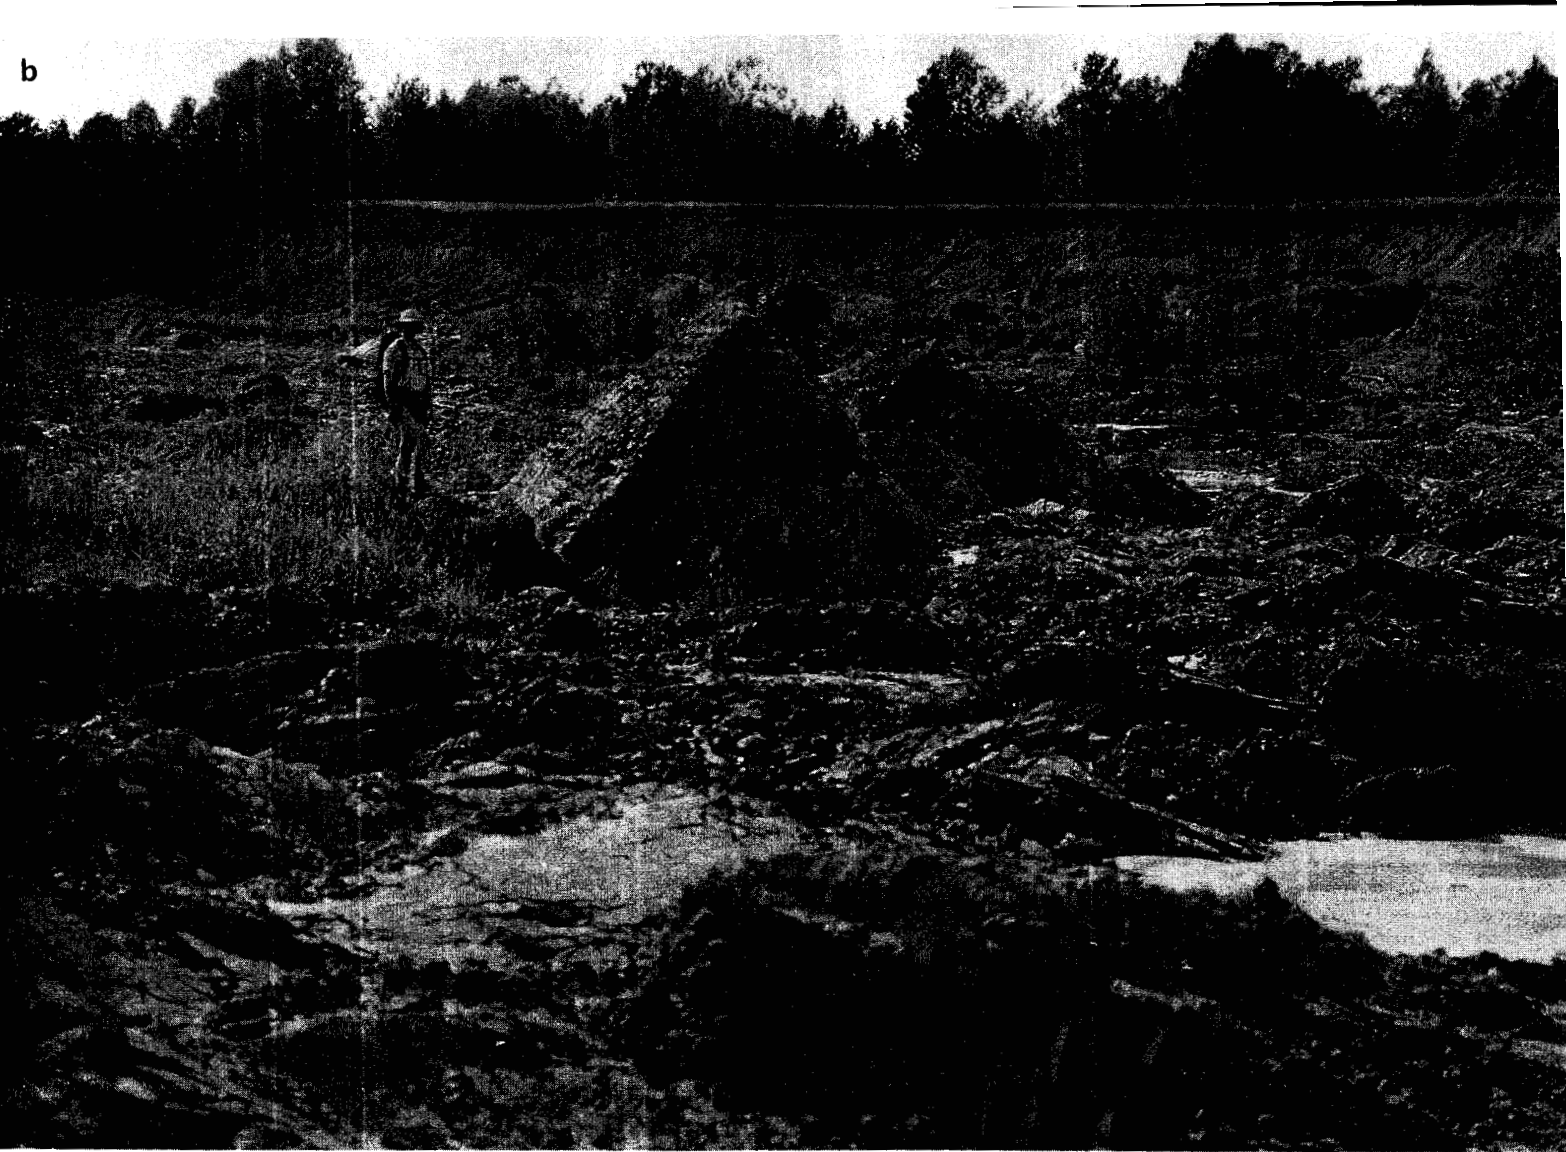
Figure 10. *a) Sharp-crested ridges and b) prismatic-shaped blocks of intact sediments are prominent features of the spoil particularly within upper part of the crater; note the person for scale. The ridges are composed of horizontal interbeds of clay, silt, and sand which are visible in b). The comparison of the interbeds within the ridges and blocks with the intact deposits of the sidewall suggests that there has been some subsidence as well as translation.*

Because of the horizontal nature of the interbeds, these ridges cannot be attributed to rotational failure, but rather to the lateral translation and differential subsidence of the blocks (see Carson, 1977). Between the sharp-crested ridges, the spoil generally consists of disturbed blocks and remolded sediments with the more disrupted and tilted blocks showing evidence of sliding along the interbeds. GSC 1993-295C; GSC 1993-295D

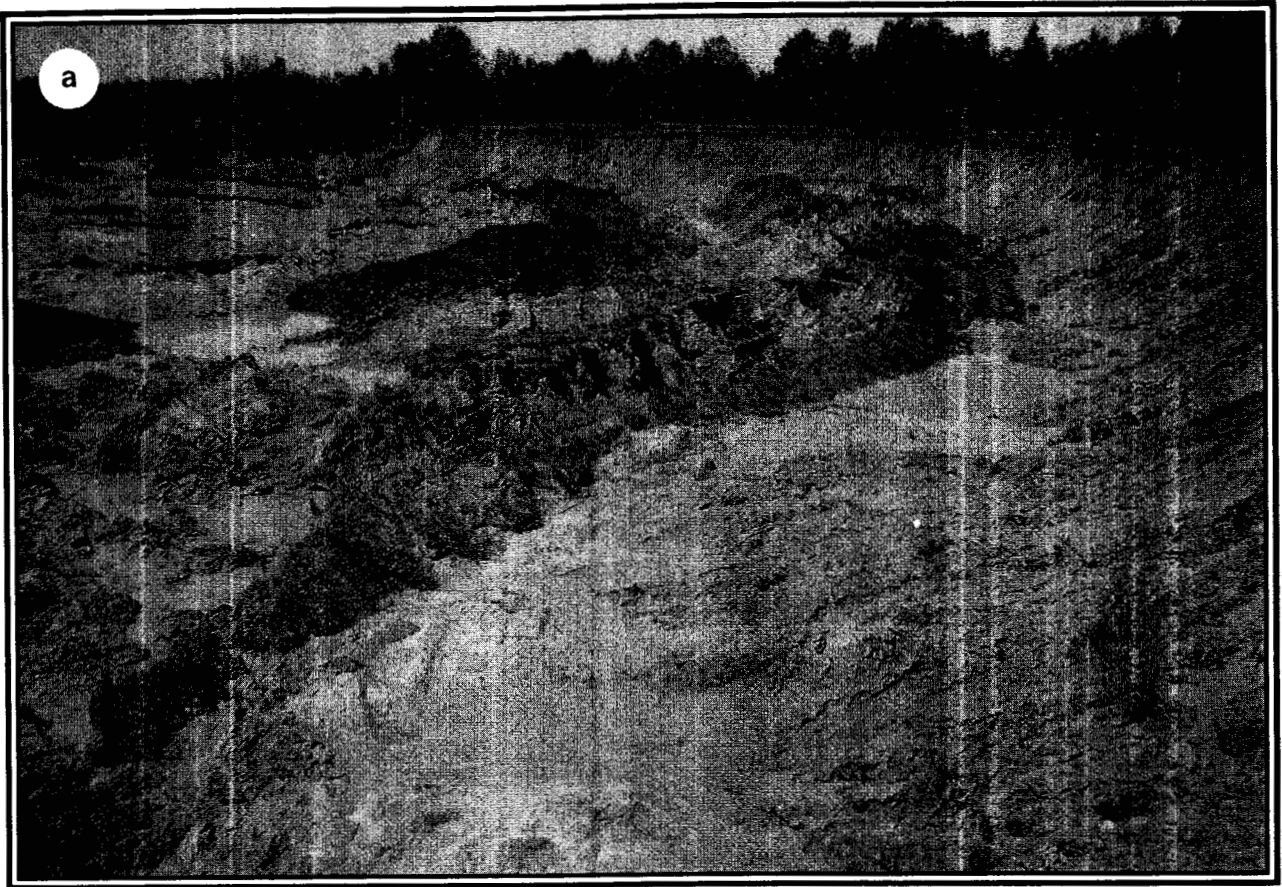
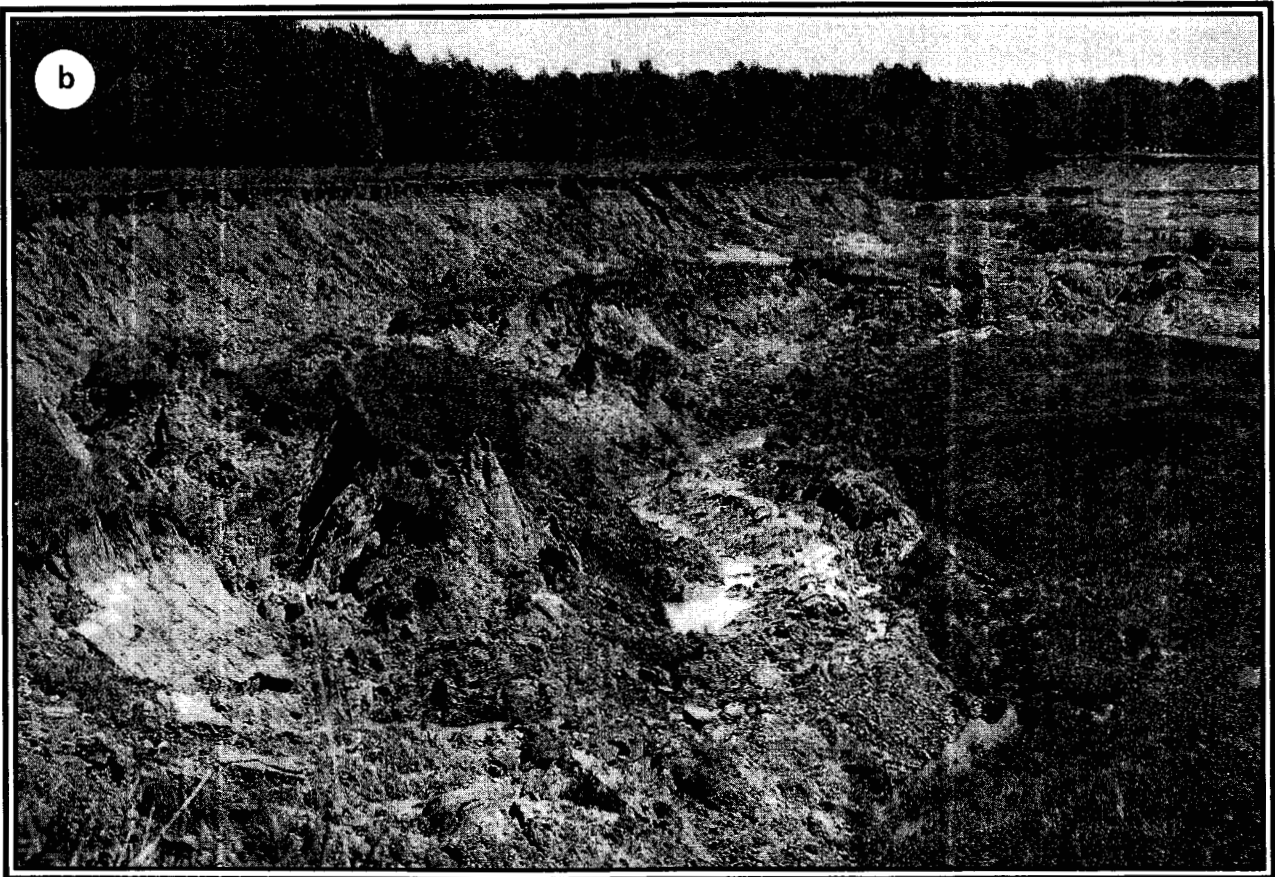
Figure 11. a) *The final stages of failure along the embayment on the north side of the crater occurred as rotational failures rather than subsidence and translation as on the south side. Two rotated blocks are visible in this photograph; their surfaces dip towards the sidewall. Also visible in the photograph at the base of the sidewall are micro-alluvial fans formed by seepage which carried sand and silt from the crater side. Similar fans are common at the base of the sidewall all along the crater margin. GSC 1993-295E* **b)** *The stiff cap (sod, sand, and silt) of the last rotational block has fractured and some pieces have rotated forward. Grey silty clay was pushed out in front of the last rotational block, lifting the sod of an earlier block. GSC 1993-295F*
