RAISIN REGION CONSERVATION REPORT 1969

**A supplement to The Raisin River Report
1966**

DEPARTMENT OF ENERGY AND RESOURCES MANAGEMENT
CONSERVATION AUTHORITIES BRANCH

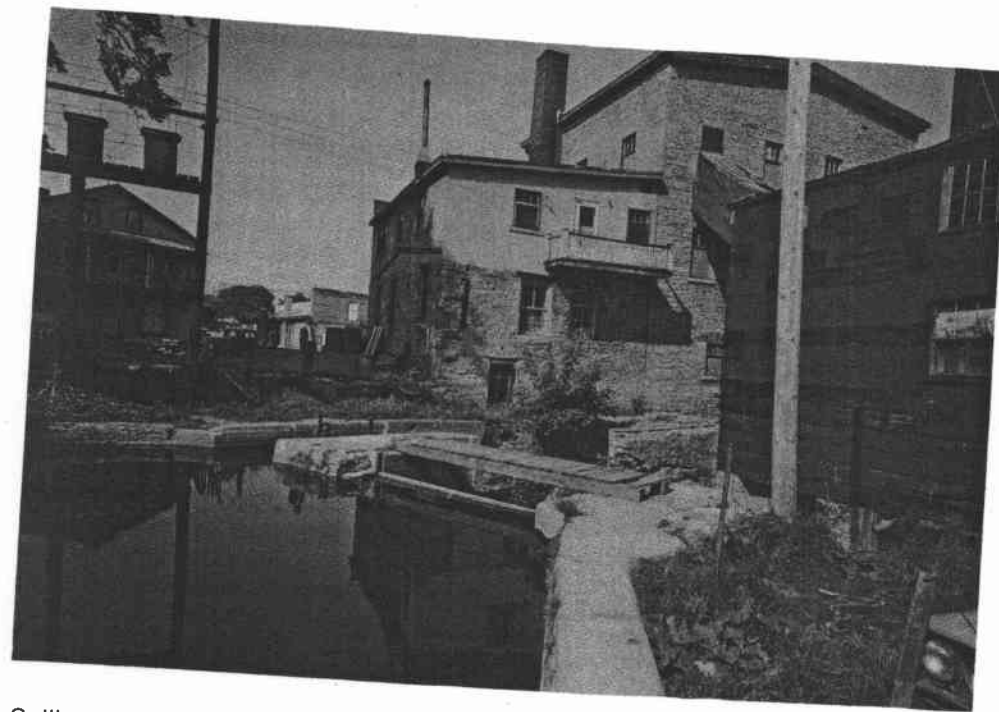
Spillway & Grist Mill at the Outlets of Mill Pond in the Town of Alexandria.

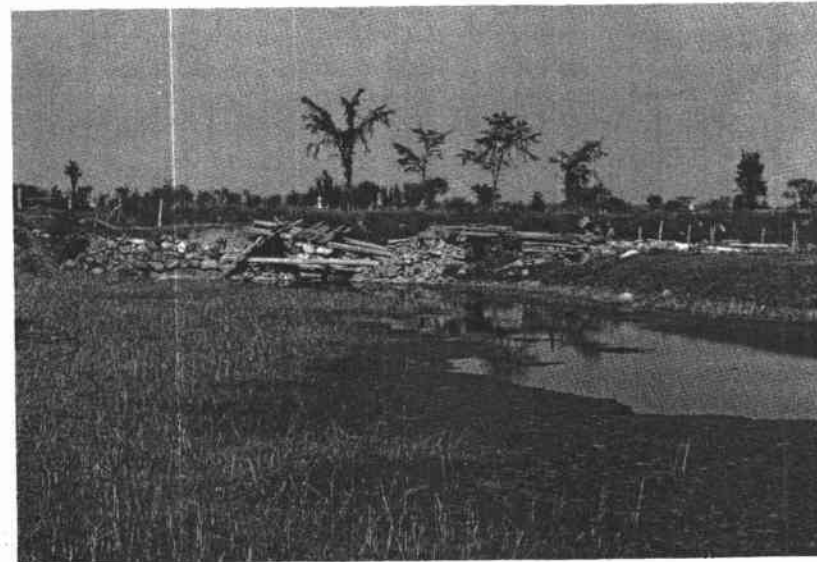
A Farm Lane Conduive to Ice-Jamming, Crossing the Rivière Delisle.

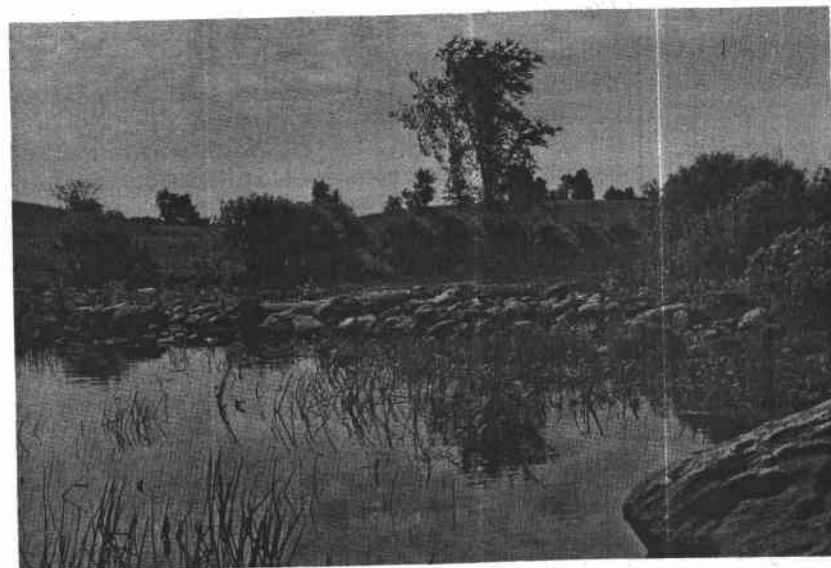
A Farm Lane Crossing Sutherland Creek.

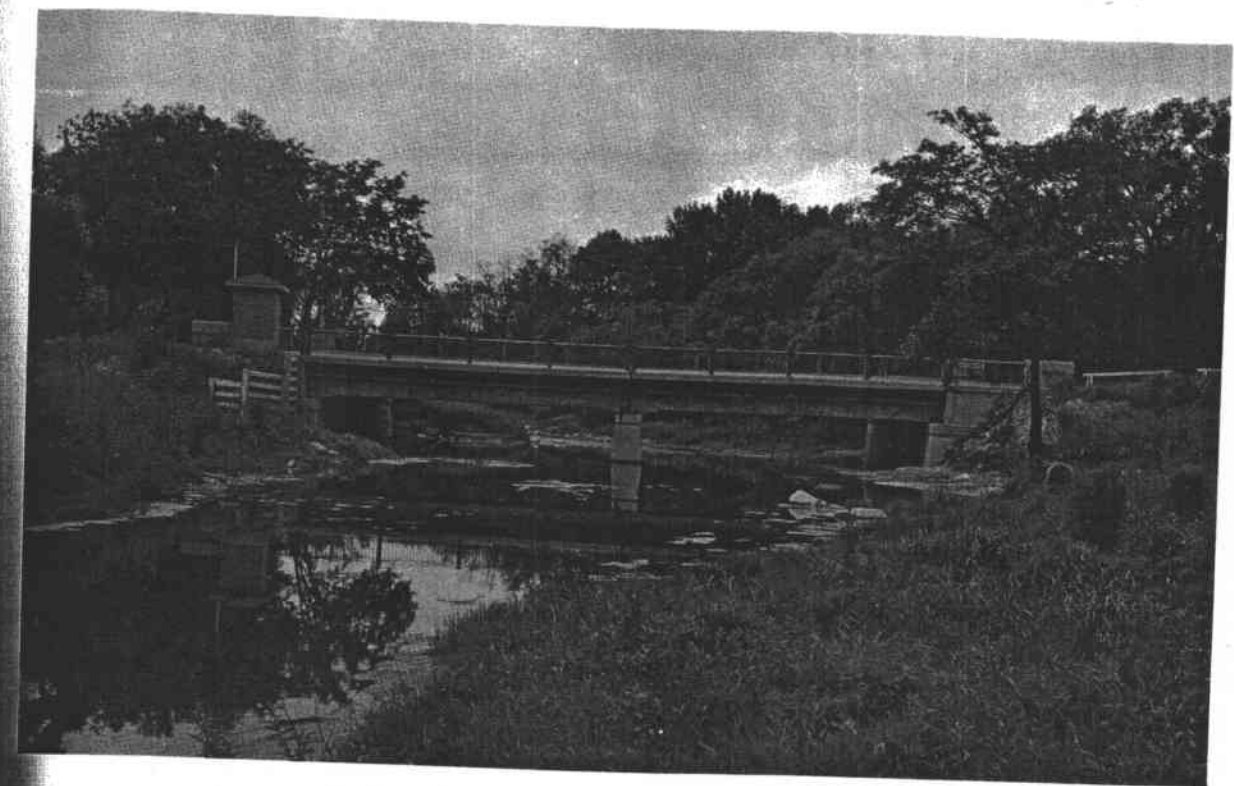
TYPICAL STREAM GAUGE STATION

The collection of streamflow data by direct measurement of velocity and water surface elevation is known as stream gauging. The types of gauges in general use are the staff and box (tape and weight) gauges which are read manually, and the clock-run automatic gauge-height recorders. The latter type are usually installed at permanent stream gauging stations like the one illustrated in Figure 12. Manual gauges have a much lower initial cost but, unlike the automatic recorder, do not yield a continuous water stage record.

The stage record is converted to a discharge record by metering the stream. The river is cross-sectioned at the gauge site and flow velocity is measured with a current meter. The cross-sectional area multiplied by the average velocity yields the discharge measurement. Periodic meter measurements of flow, and simultaneous stage observations provide the data required to develop a rating curve. The flow at any particular stage can thereafter be determined from the stage records by the use of a rating curve for the gauging site.

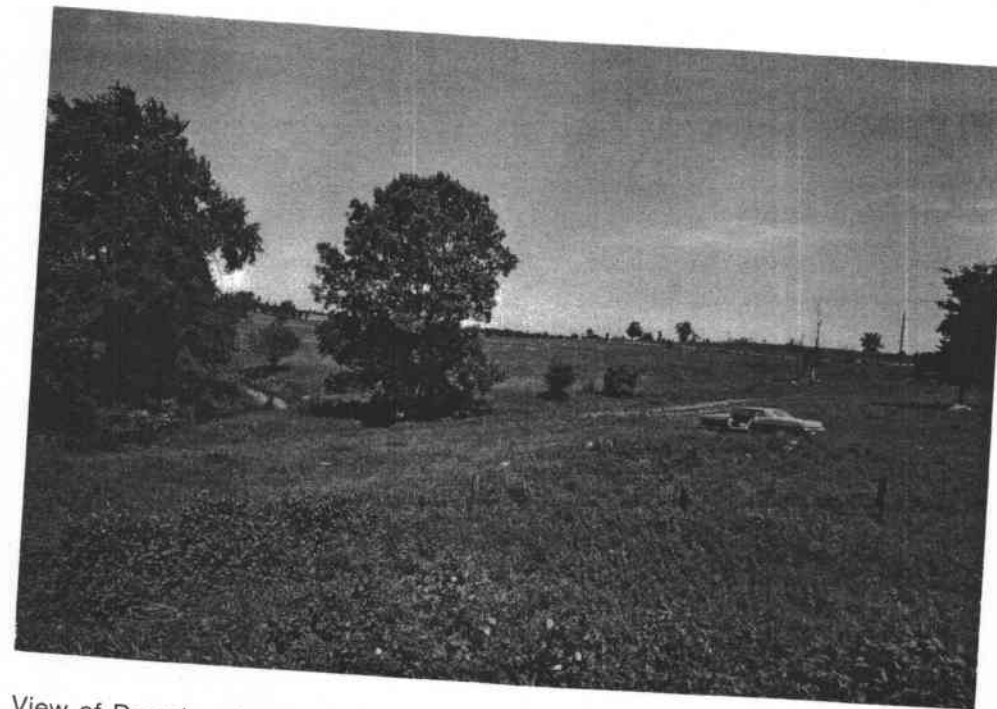
View of Dam site of Proposed Green Valley Reservoir on a Tributary of Rivière au Beudet, Looking Upstream from C.P.R. Tracks.

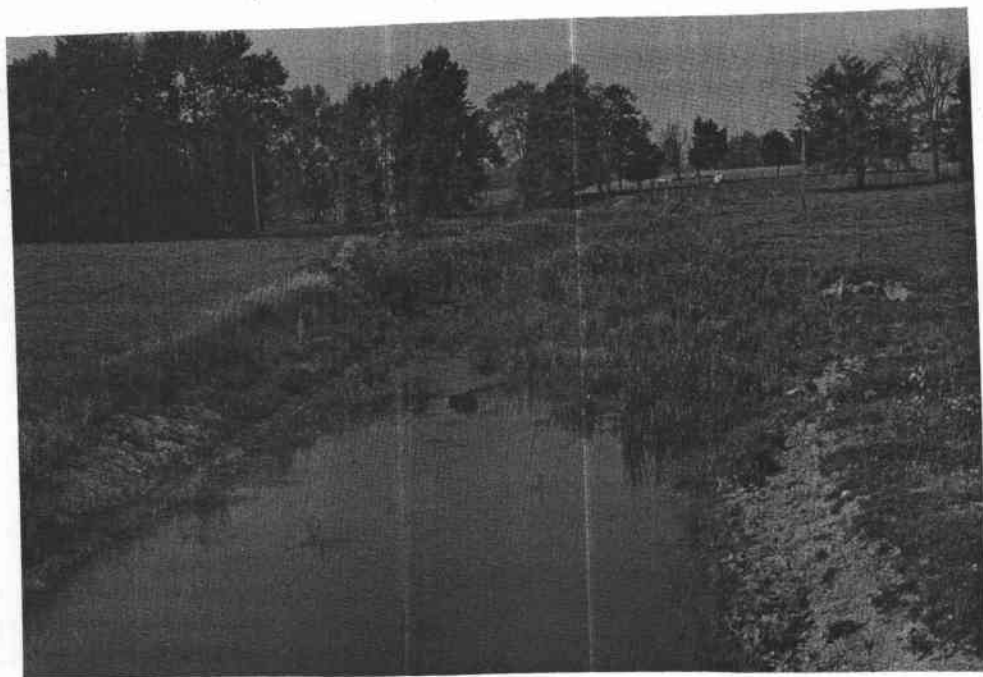
Deteriorated Channel of Sutherland Creek.

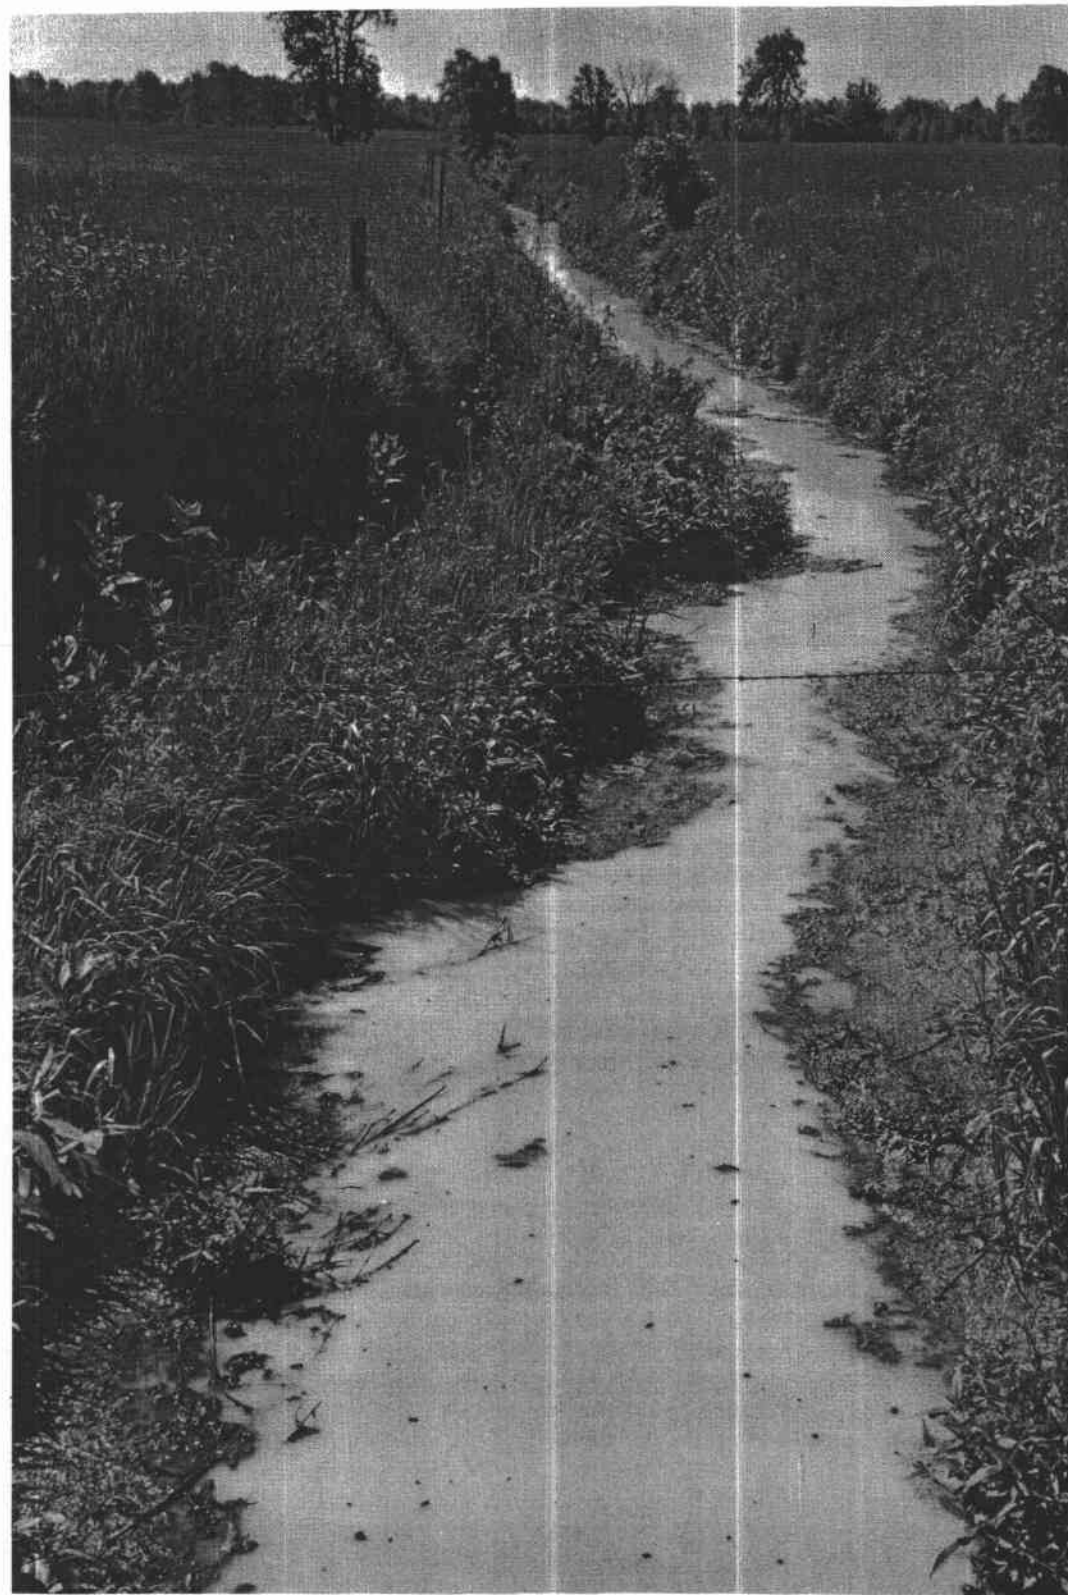
The Polluted Tributary A of the Rivière au Beaudet Flowing into Ontario from Quebec.
