**Apple Hill  
Communal Water Project  
Class Environmental Assessment  
Environmental Study Report**

**M.S. Thompson & Associates Ltd.**

**Project No. 94519**

**November 24, 1999**

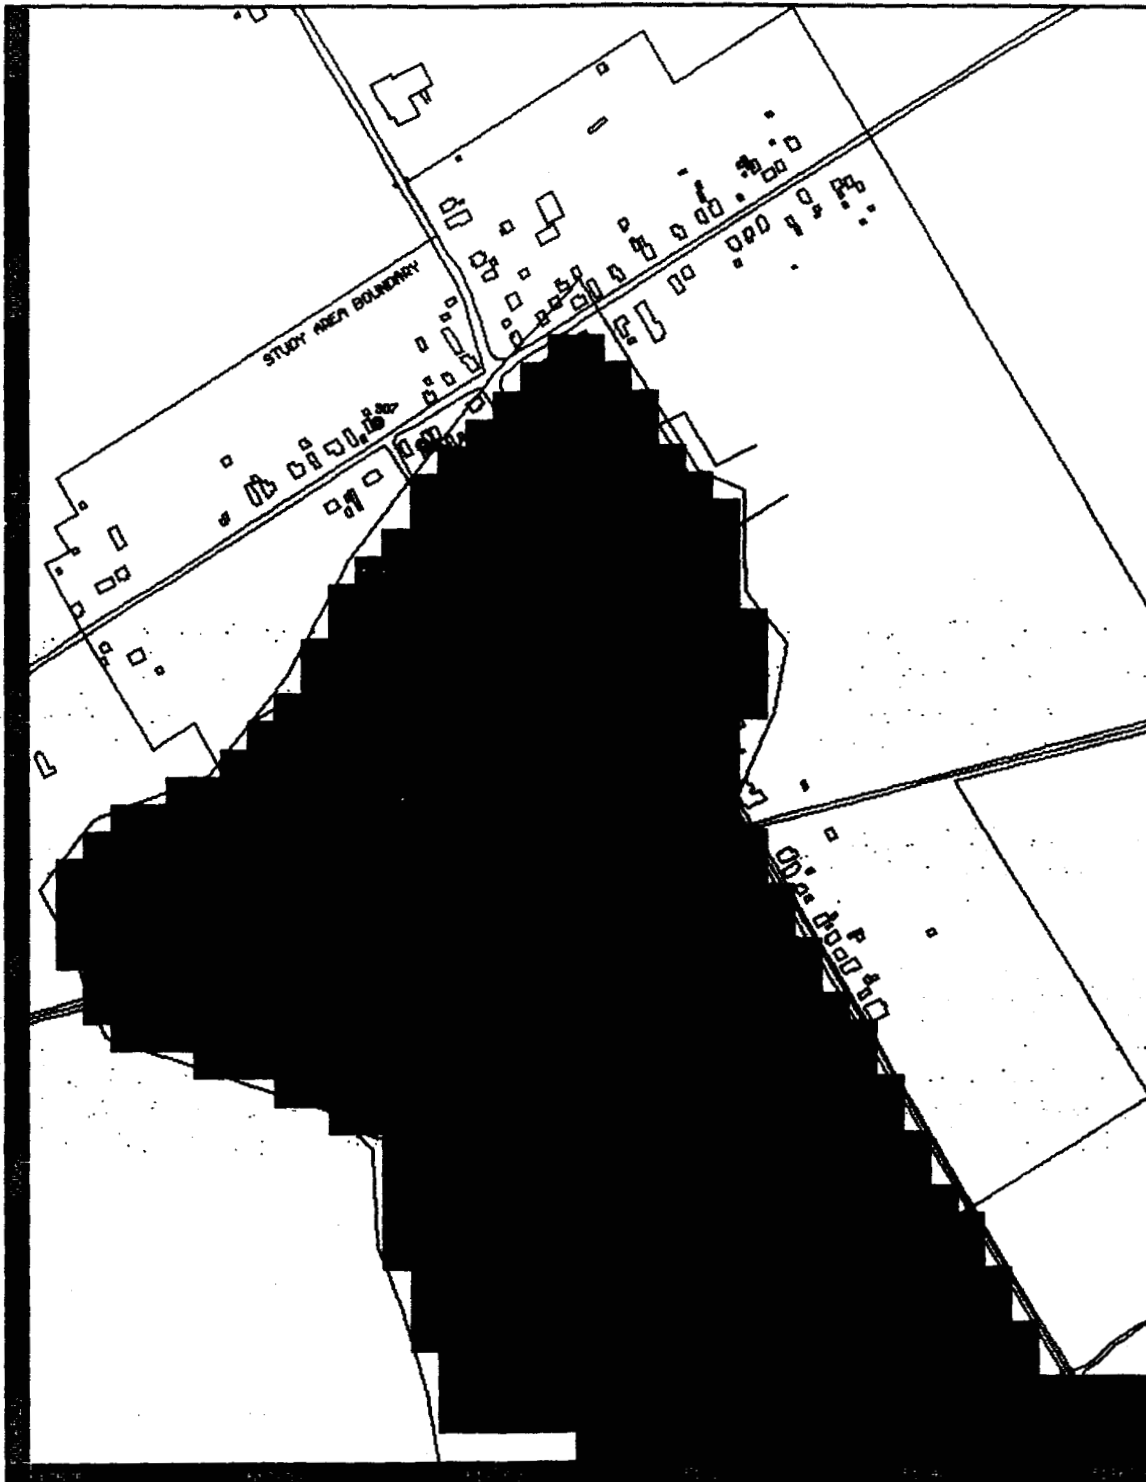
blue = 100 mm/yr, green = 300 mm/yr, purple = 450 mm/yr, red = 500 mm/yr  
**Figure 7: Model 1, recharge distribution**
