**COMPLIANCE INSPECTION REPORT**

**The Nation Township  
(Cambridge)  
Waste Disposal Site**

**SOLID NON-HAZARDOUS  
WASTE DISPOSAL SITE**

**Inspected by: Marc Robert  
Inspection: November 18, 1999**

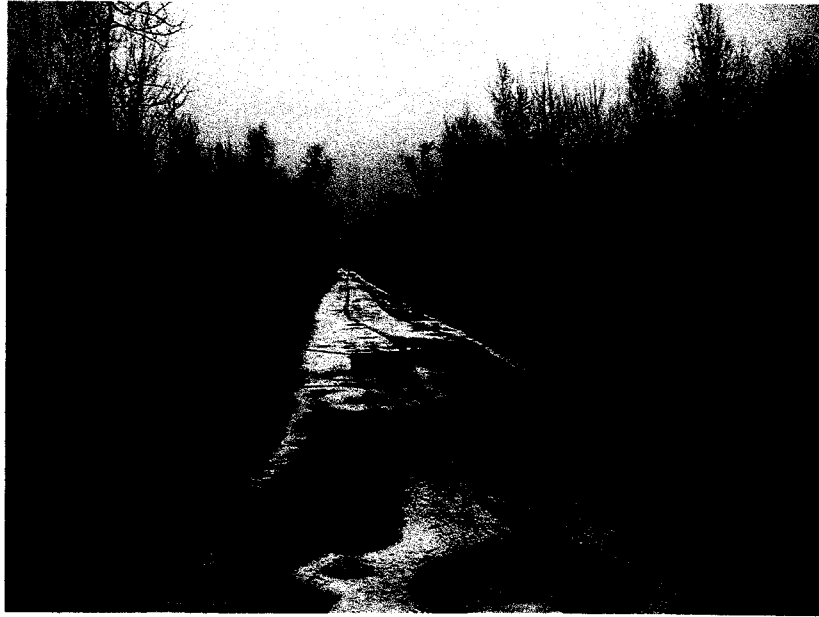
There are two entry points to the waste disposal site: a main entrance to the site off of County Road 3 (photo No. 4) and another secondary entrance located behind the Nation Township municipal offices and garage (photo No. 5). Access to the site is controlled somewhat by a locked chain that traverses each of the entrances. There is no fence around the landfill site. At the time of my inspection, the chain was in place across the main entrance to the site and was not in place across the municipal offices' entrance. I have visited the landfill site on a few other occasions since my inspection and have observed that when a site attendant is not present the main entrance is locked whereas the municipal offices' entrance has always been open.

**Photo 4: Main entrance to the Nation  
(Cambridge) waste disposal site.**

The municipality should ensure that the municipal offices' entrance to the waste disposal site is locked when a site attendant is not present on site.

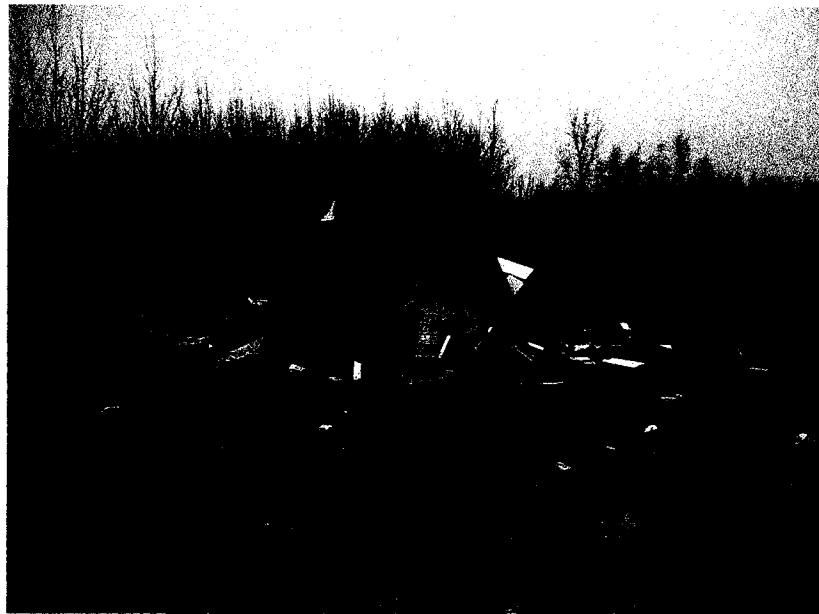
Also, there was evidence of small uncovered piles of waste that had been deposited outside of the footprint for no apparent reason (photos No. 9 and 10).

Photo 9: Pile of uncovered waste.

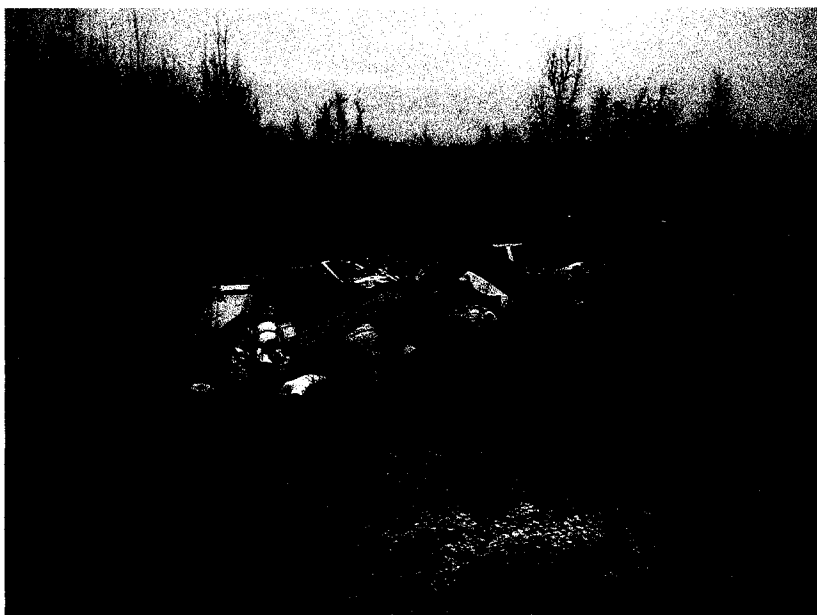
Photo 10: Pile of uncovered waste.

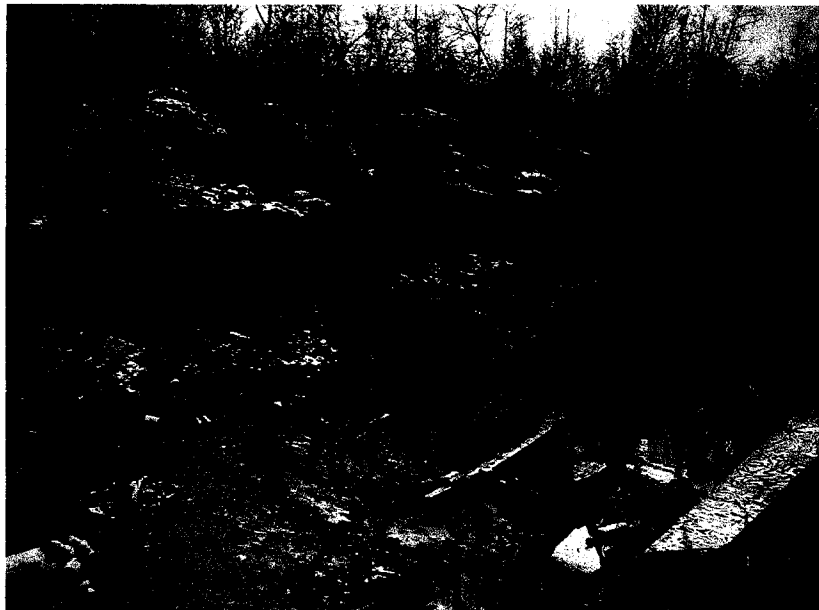
Photo 15: Water flowing from under landfill site access road.

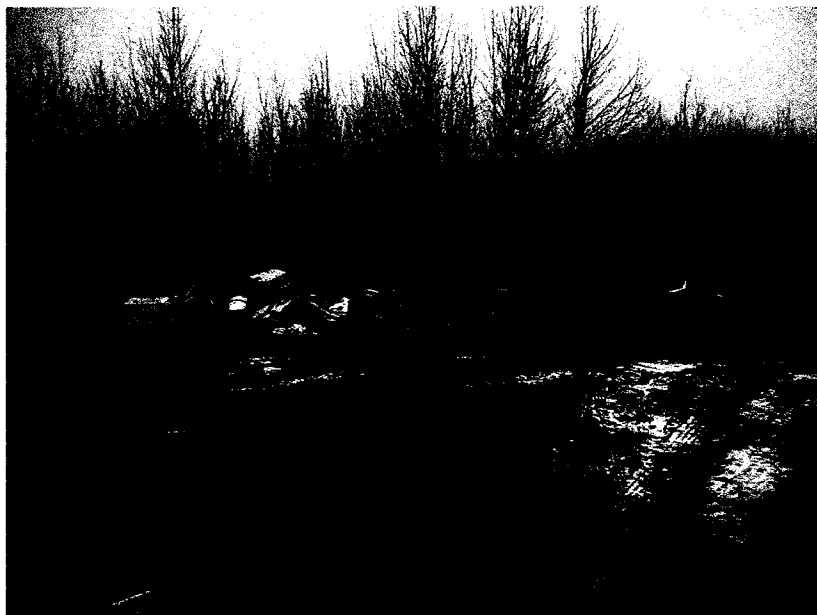
Waste refrigerators were visible amongst the pile of scrap metal at the site (photo No. 18). Although it was not possible to ascertain whether they had been tagged

free of ozone-depleting substances, they likely did not contain refrigerants because the metal lines to their compressors had been severed.

Photo 18: Scrap metal storage.

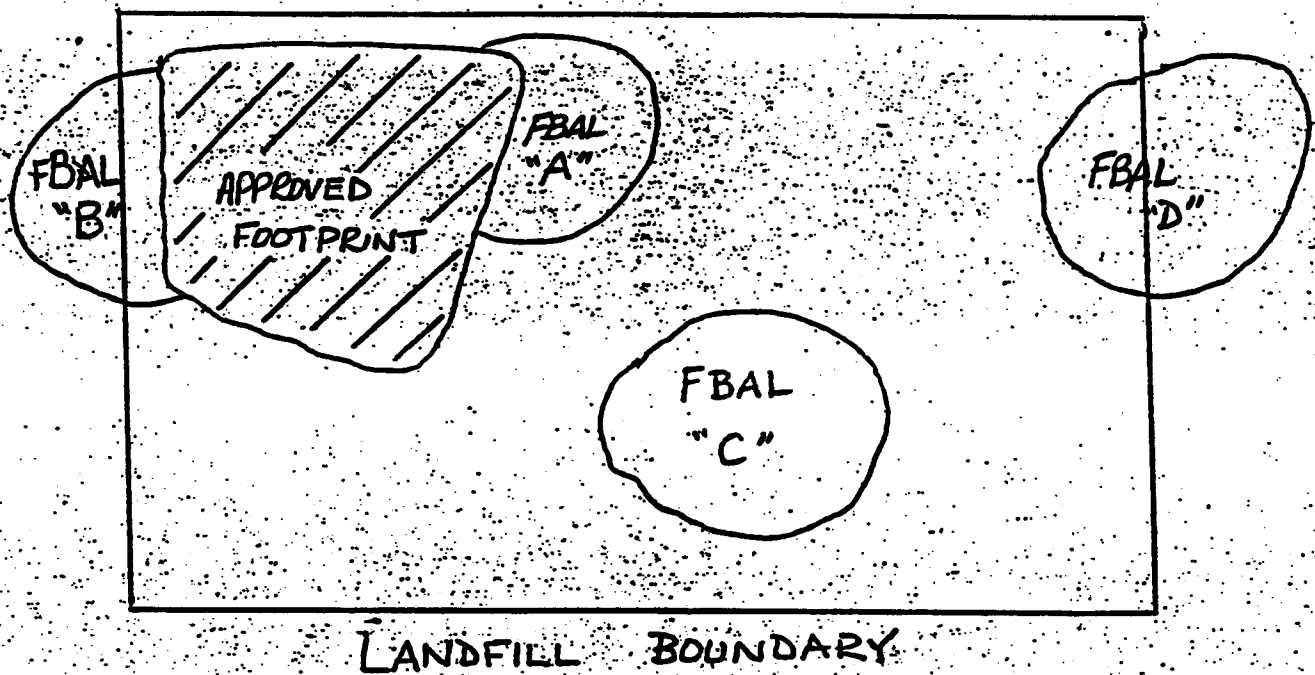
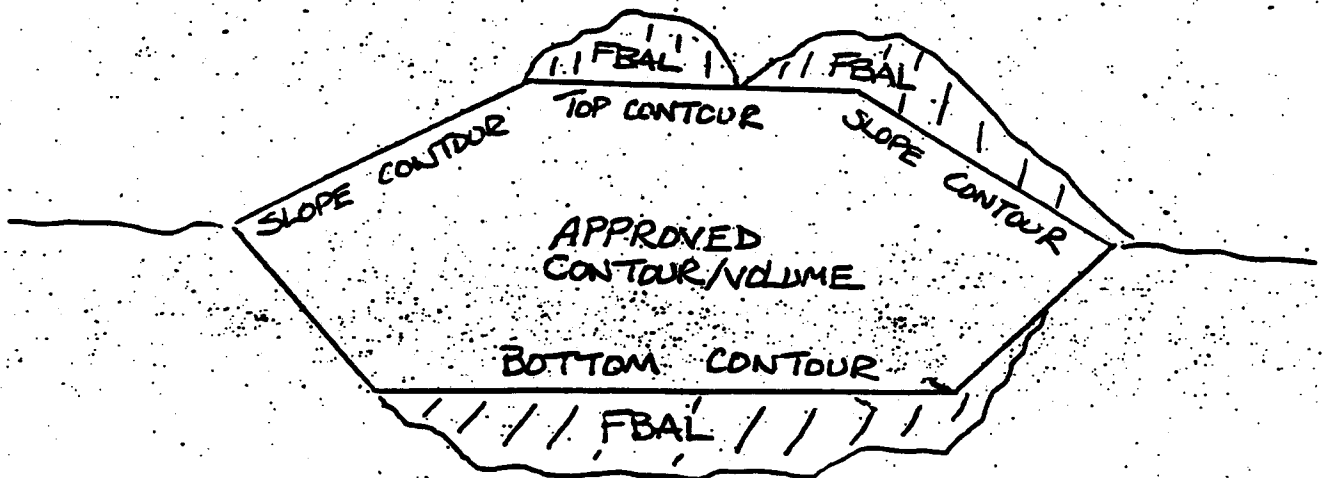
# DIAGRAM #1

**1. Fill Beyond Approved Limits, (FBAL) -** occurs where waste is disposed of outside of the approved footprint which in it self has remaining capacity for waste disposal, this is defined as "fill beyond approved limits". Fill Beyond Approved Limits, may occur under the following circumstances, (see Diagram 1):
