An earthflow in sensitive Champlain Sea sediments at Lemieux, Ontario, June 20, 1993, and its impact on the South Nation River¹

S.G. EVANS AND G.R. BROOKS

Can. Geotech. J. 31, 384–394 (1994)

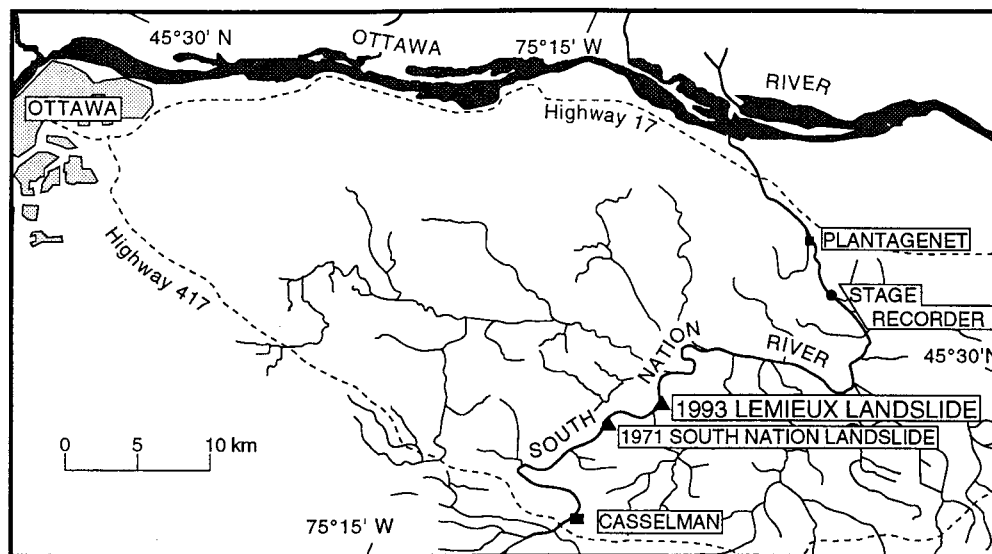
The debris dammed the South Nation River, causing flooding upstream. In addition, when the river overtopped the debris dam 3 days later, it adversely affected water quality for agricultural and domestic use downstream. Trees washed out of the debris were also a hazard to boaters along both the South Nation and Ottawa rivers.

FIG. 1. Aerial view of the 1993 Lemieux landslide which took place on June 20, 1993. View is toward the southwest looking up the South Nation River. Severed County Road 16 is seen at bottom left and County Road 8 bridge discussed in text is seen upstream of the landslide in the middle distance. Note impoundment of river and upstream flooding. Photo taken on June 23, 1993.
