**CHESTERVILLE INTERIM
FLOOD CONTROL PROJECT**

GROUNDWATER STUDY, SOUTH NATION RIVER

**Evaluation of Effects of
Proposed Channelization on
Water Wells**

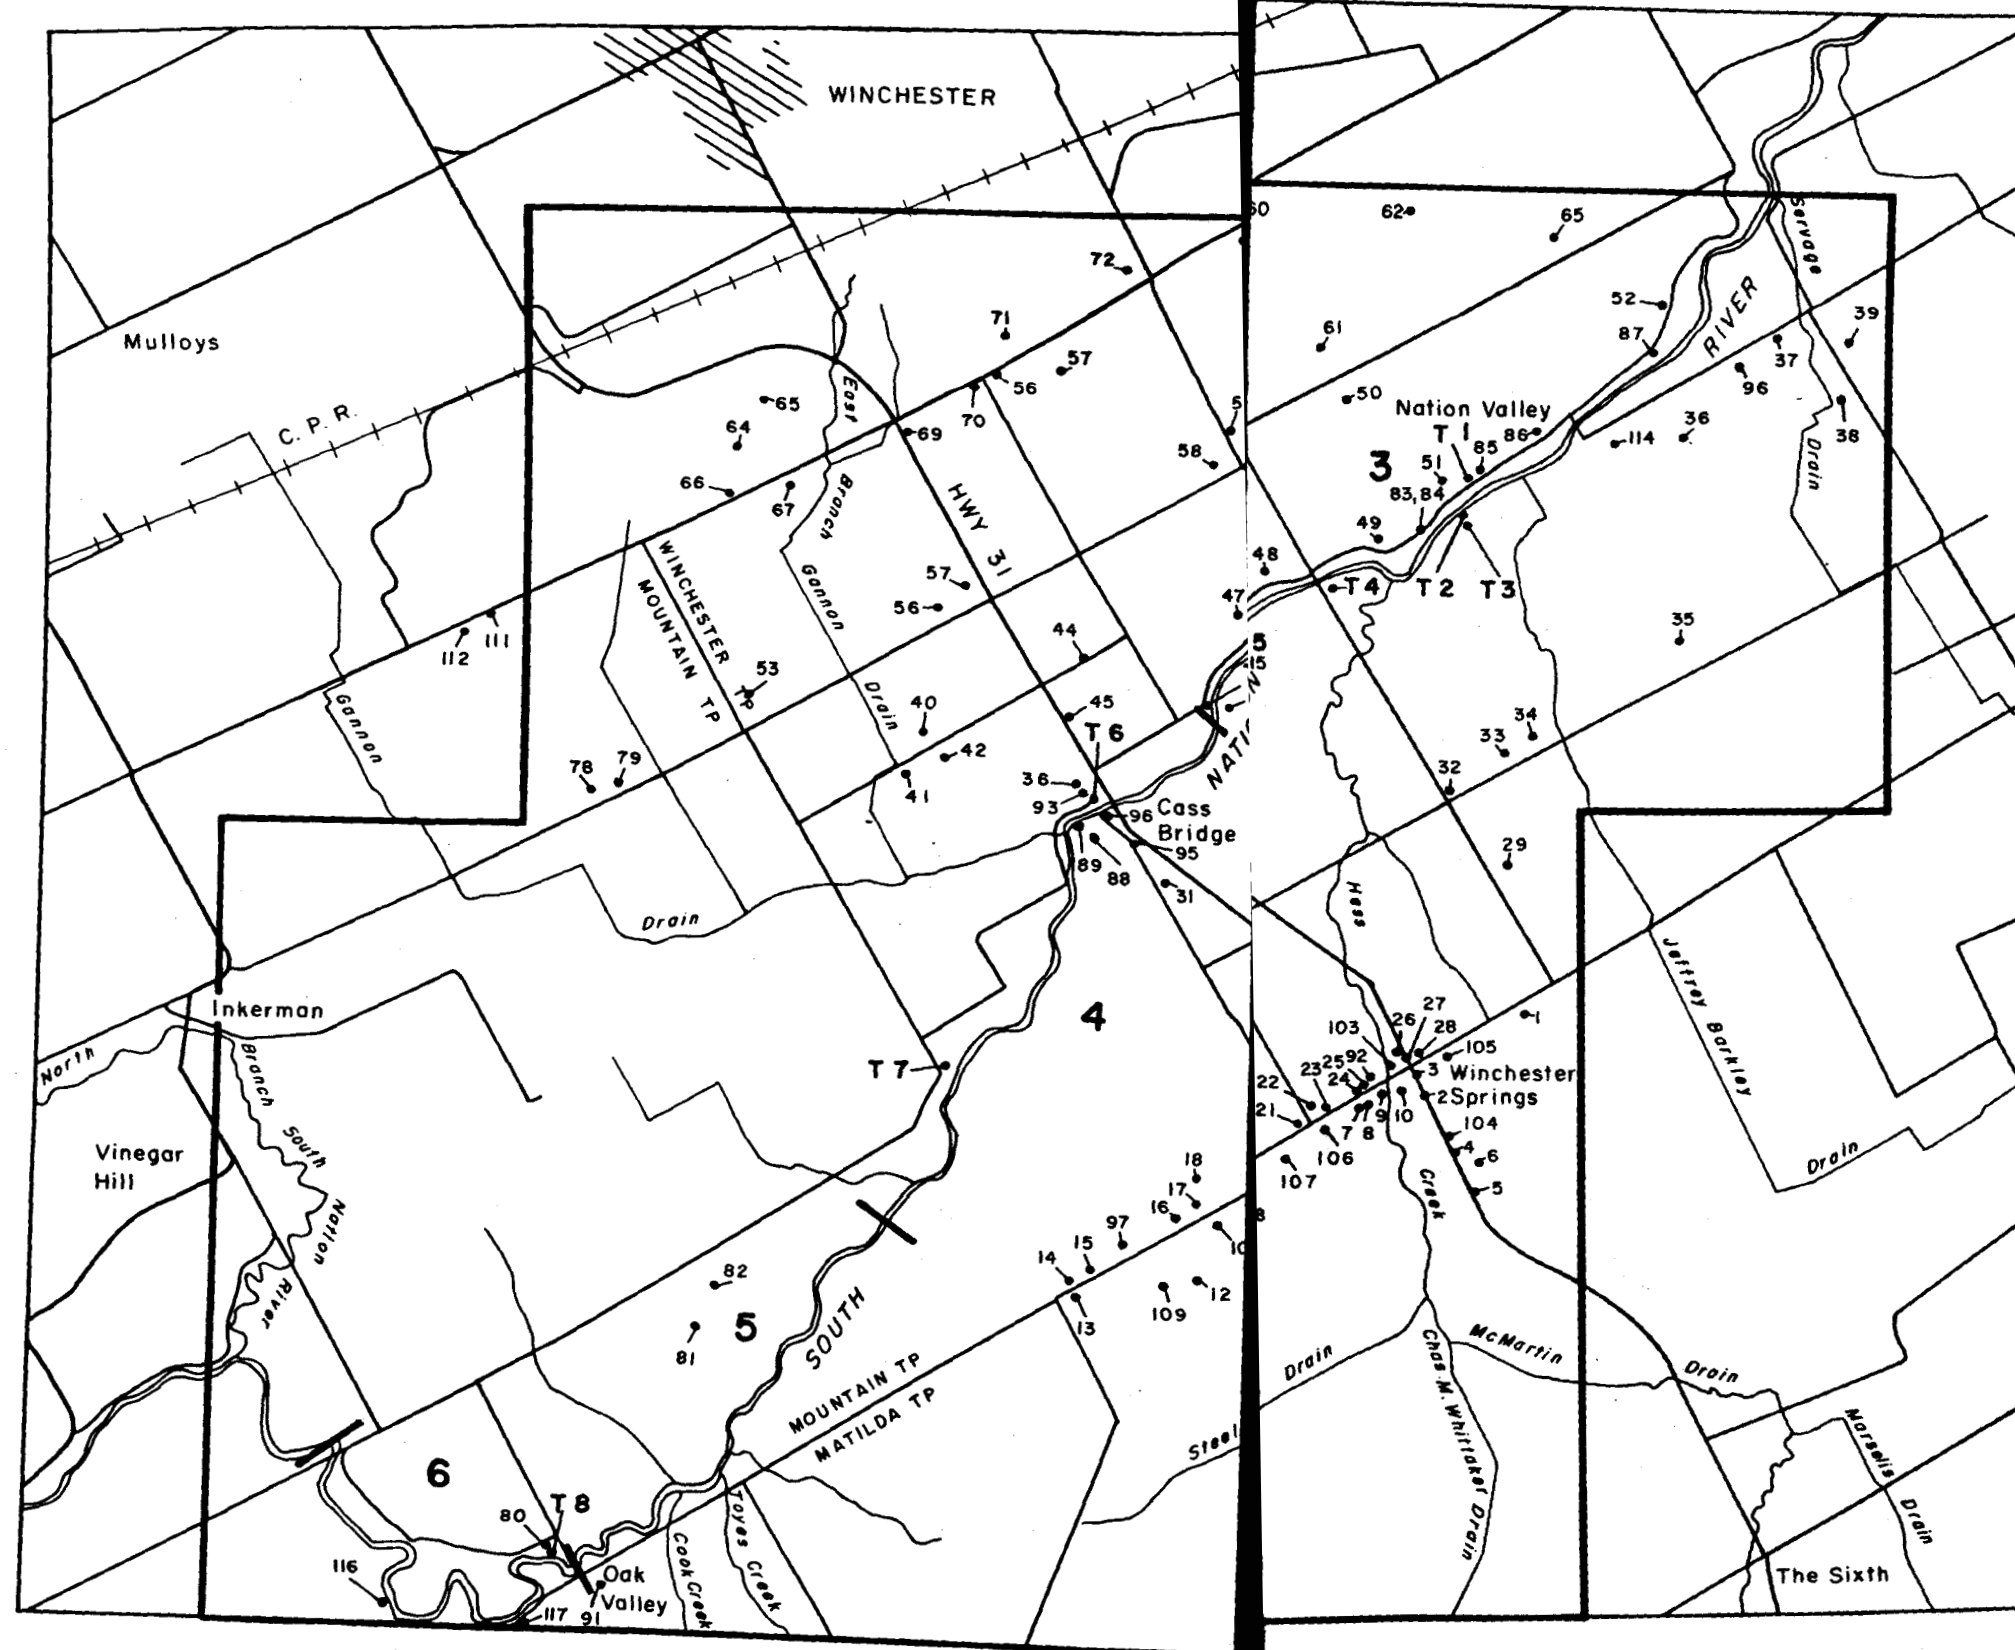
FIGURE 1

WELL LOG AND
CONTRACT AREA
LOCATION MAP
SOUTH NATION RIVER

A total of 118 water well records located for the study area were collected and plotted at a Regional scale. (These data are included as Appendix A.) Well locations are shown on Figure 1. Bedrock contour, gravel distribution and potentiometric maps were produced from this data. A house-to-house survey was conducted of all residences within one-half kilometre of the river in Contract Areas 3, 4, 5 and 6. A prepared checklist of well design, water use and related information was completed at each residence. Each water supply was sampled for chemical and bacteriological analysis. Driller's water well records were matched to each farm and residence wherever possible. The resulting information is synthesized in Appendix B of this report.

To provide essential background information for our work, the geology and hydrogeology of the study area was investigated at a Regional scale. An approximately three kilometer corridor northwest and southeast of the South Nation River was included (Figure 1) and data were plotted on a 1:50,000 base map.

Test holes are also located on Figure 1.
